Personal Protective Equipment Conformity Assessment Studies and Evaluations

Evaluation of Six Self-Contained Breathing Apparatus for Potential Contribution to a Fatal Event in the Fire Service

Wilmington Delaware Fire Department Request for five MSA Model Firehawk[®] M7 and one MSA Model G1 units

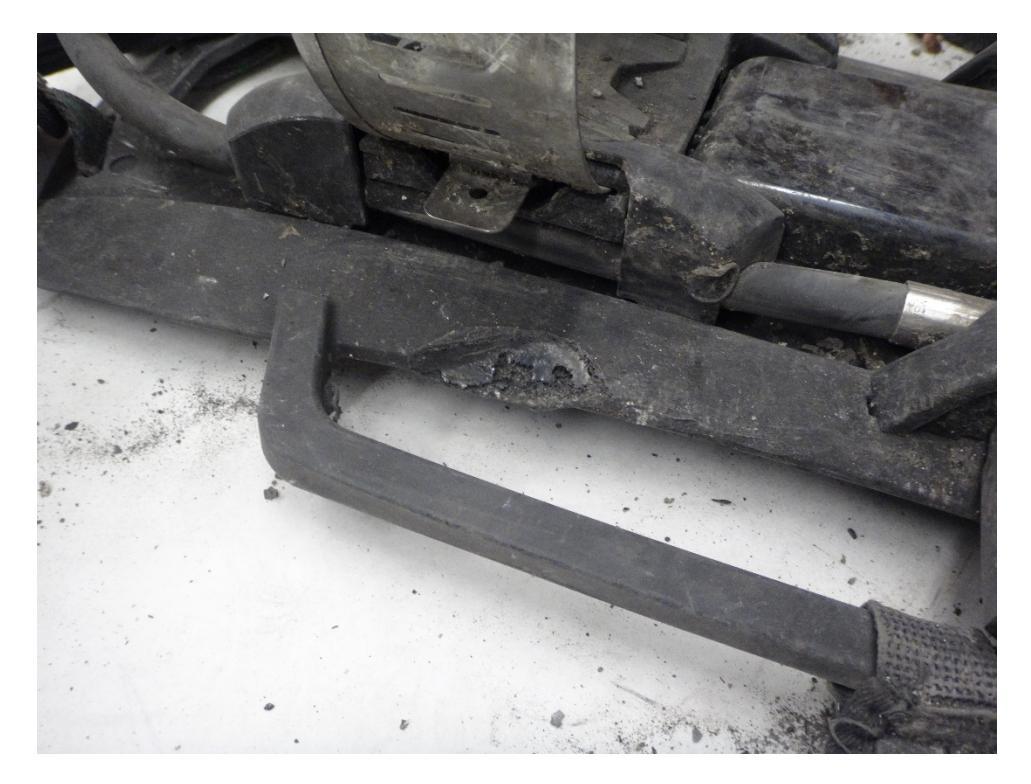
- S/N: 7-2180-1
- SEI label 1981-2013 edition
- NIOSH Approval Number label: TC-13F-0798CBRN
- Overall condition was fair
- Melting of the left railing was present
- Debris was found everywhere
- Shoulder straps were attached to the frame

Figure 20: Heat damage to side rail

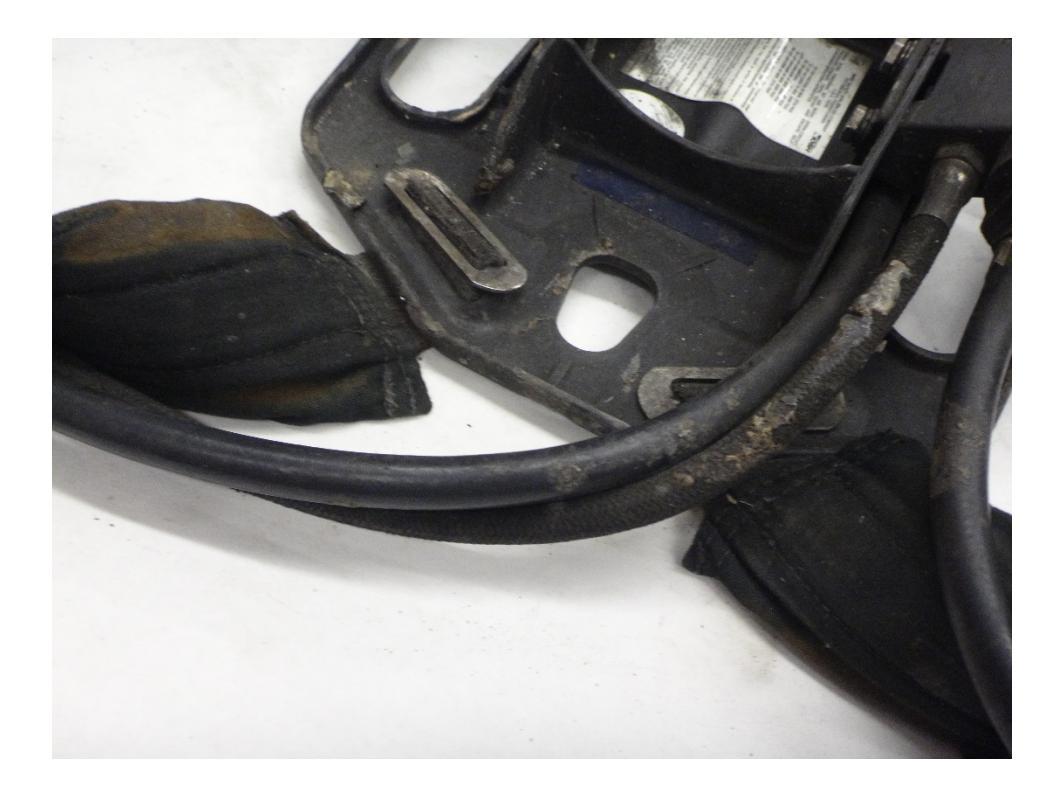
- Barcode: was not visible; US Patent#: 5,097,826; P/N: not found
- Model#: 7-2183-1l; FCC ID P9R-10075346
- Overall condition was dirty with scratches
- Melted debris/material was on the high pressure lines going to the PASS
- Gauge lens was partially readable
- Protective casing was very dirty
- Sticker: 10083540 Telemetry

Figure 43: Heat damage and melted debris on medium pressure lines to PASS console

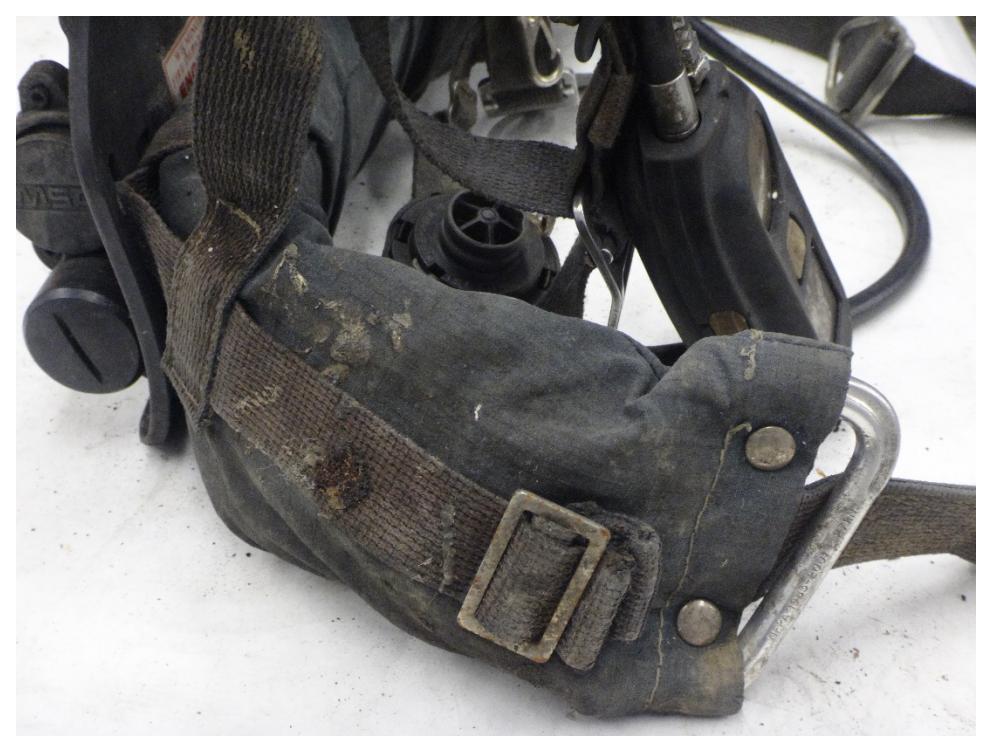
- Overall strap condition was dirty with debris and heat damage (dye sublimation), including the waist belt
- Hose lines passed through the shoulder straps
- All adjustable buckles moved and held in place
- Waist area buckle latched and released

Figure 50: Heat damage to waist belt

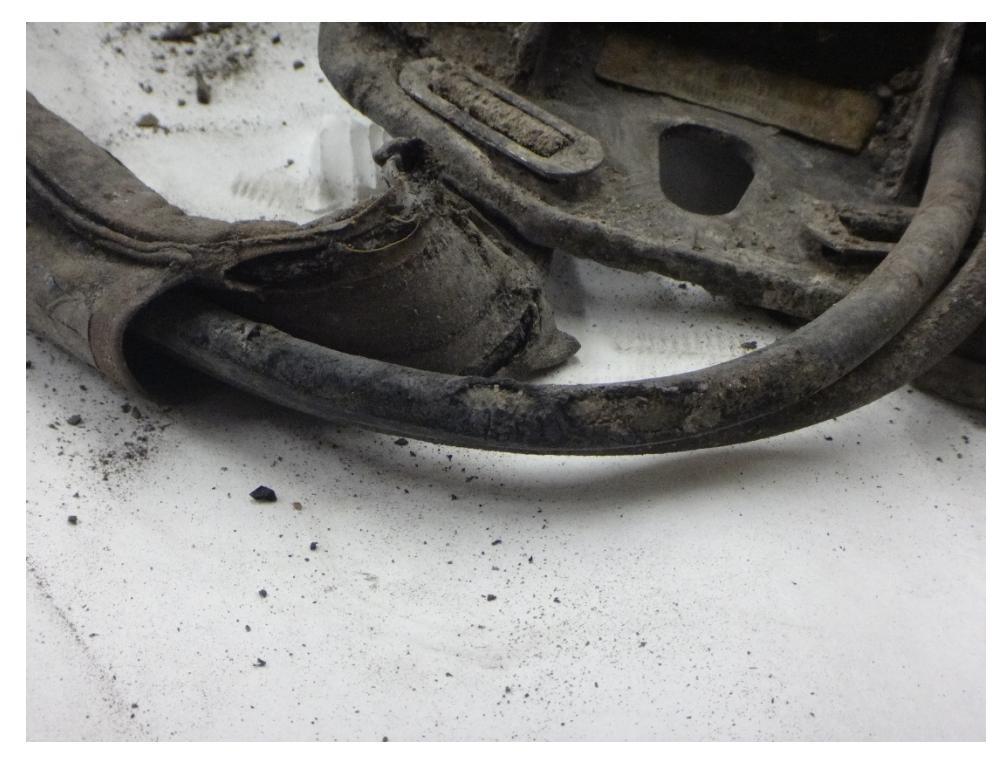
- Secured at all attachment points
- Line was in fair condition
- No Quick Disconnect
- Line passed through the shoulder strap to the reducer, but some melted plastic between shoulder strap and pressure reducer

Figure 71: Damaged medium pressure line and shoulder strap

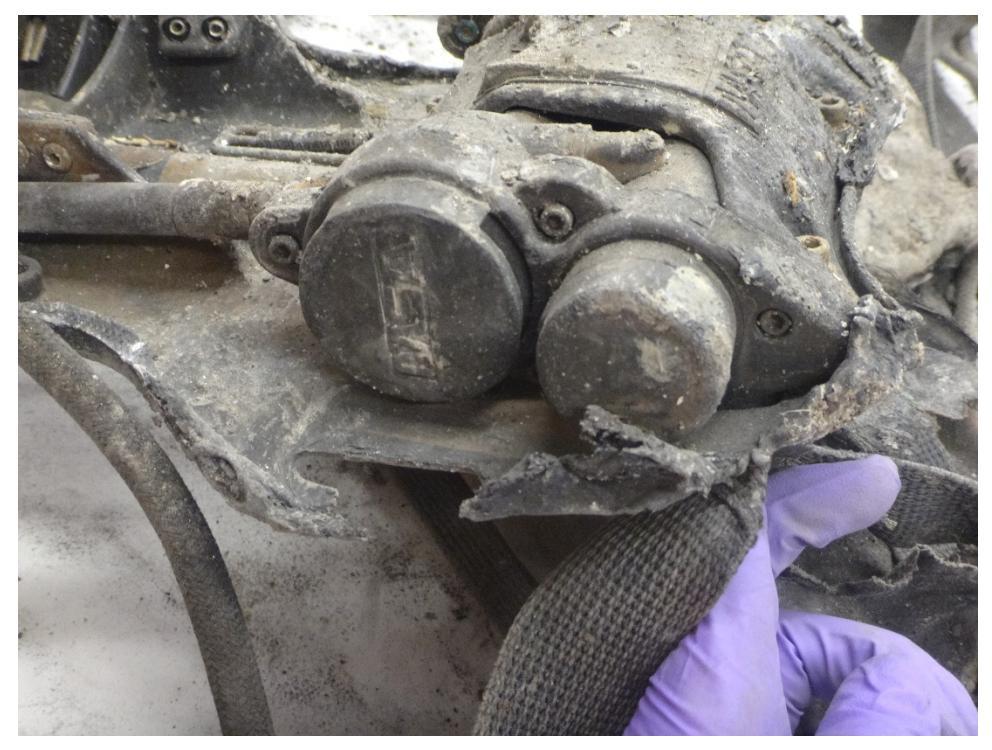
Figure 677: Left view of damage to control module and backframe

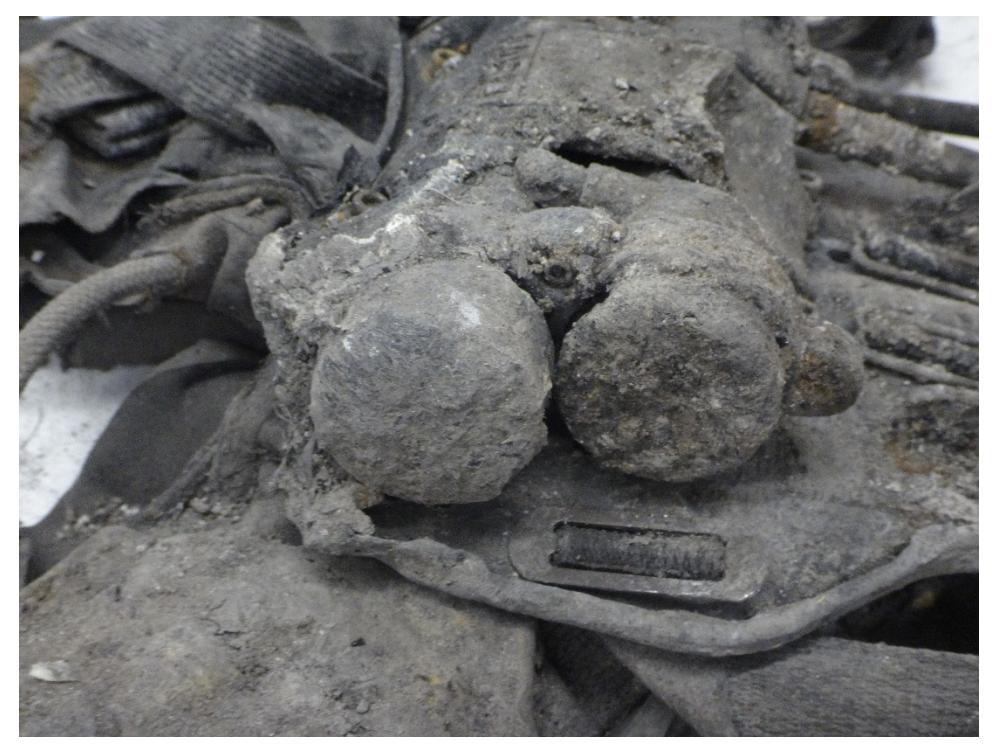
Figure 688: Right view of damage to control module and backframe

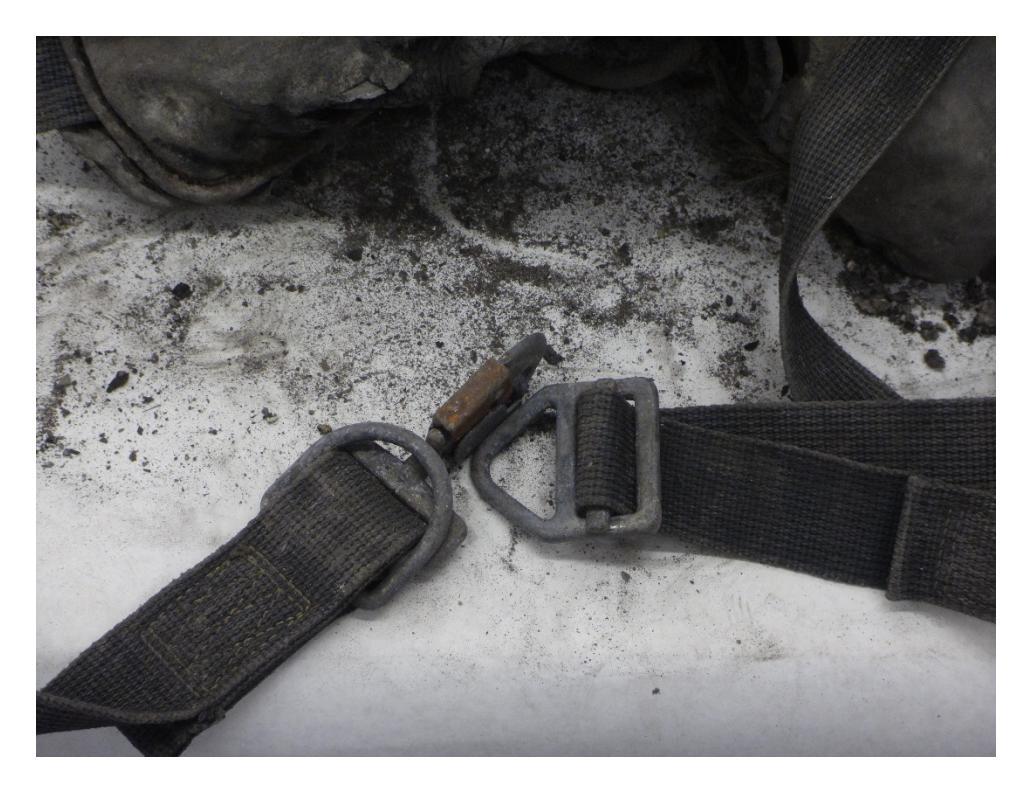
Figure 8371: Corroded buckles

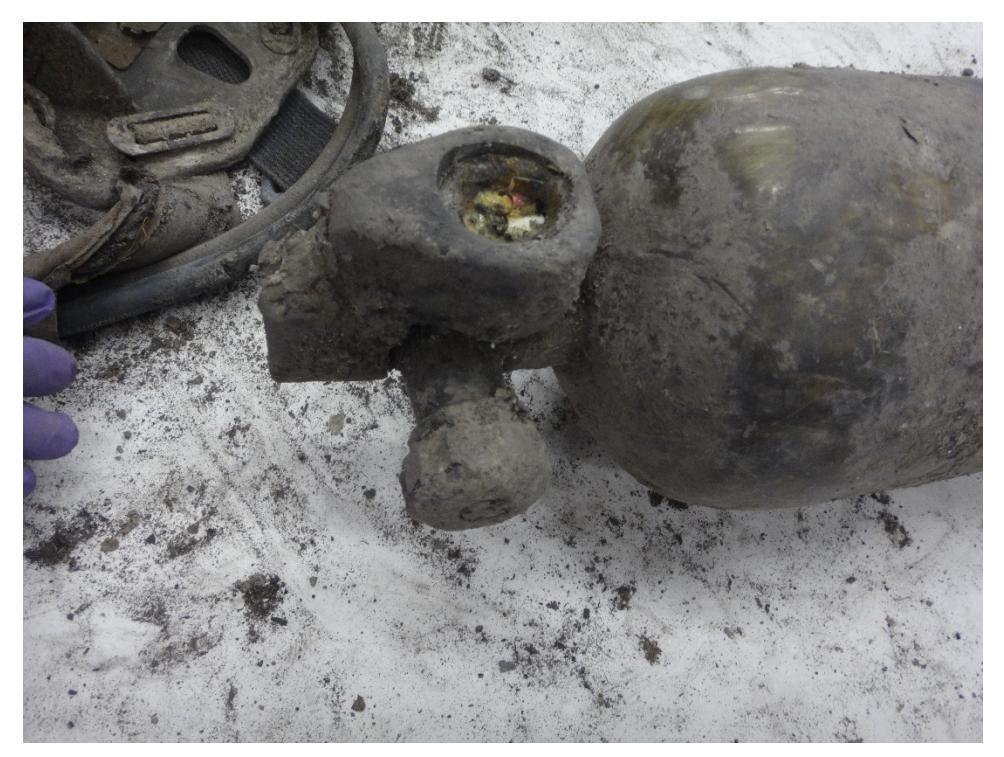
Figure 726: Damaged cylinder gauge

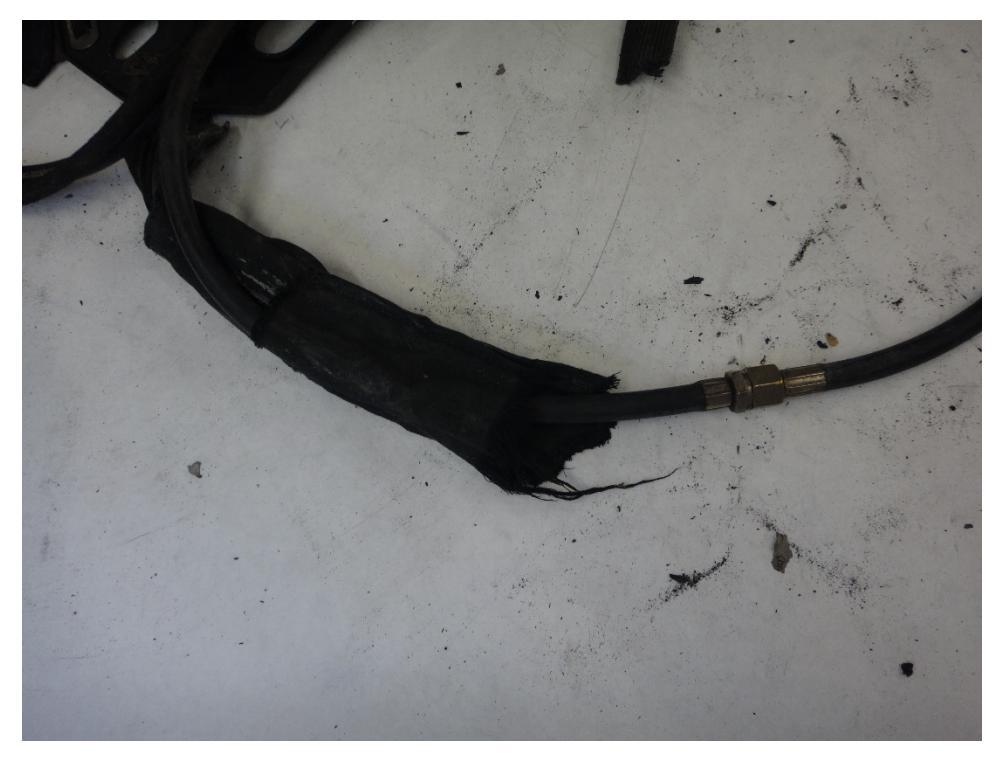
- Overall condition was good, but dirty
- Secured at all attachment points
- Right shoulder strap was burnt in two
- Line passed through the shoulder strap to the reducer

Figure 95: Low pressure line, connecting link, and damaged shoulder strap

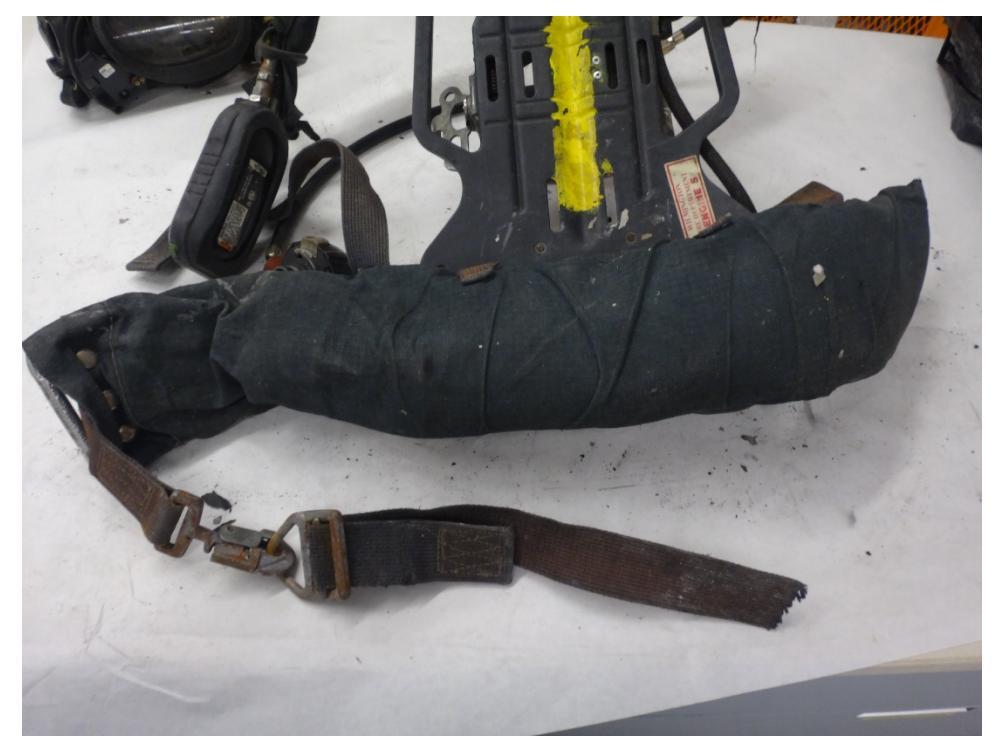
- Overall strap condition was very poor
- Only right side was functional with heat damage
- Buckles were hard to move, barely functional
- Left side was completely missing
- Waist band buckle worked, but very hard to move, signs of heat damage and rust
- Left side waist buckle was ripped off of waist band
- Left side of shoulder strap was attached at backframe, but was burned in two, where it attaches to waist belt
- Right shoulder strap attached and functioned, but was beginning to rip at the top with signs of burning

Figure 868: Top view of damage to waist belt

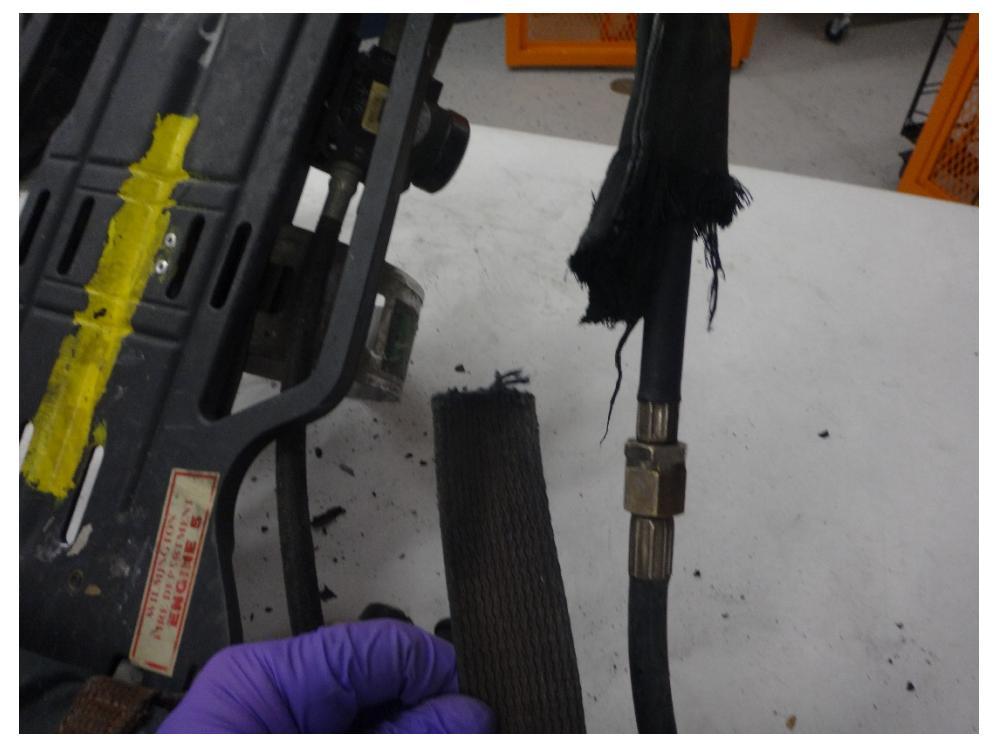
Figure 879: Damage of left shoulder strap
