NIOSH-Funded State FACE Investigation Leads to Safer Handicapped-Accessible Accelerator Pedals

DHHS (NIOSH) Publication No. 2015–186.

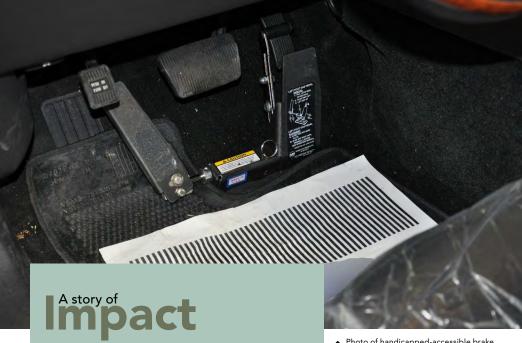
An auto technician working in the service bay was preparing a vehicle for an oil change when he mistook a handicapped-accessible accelerator pedal for the brake pedal. The handicapped-accessible pedal, which can be removed, had a left foot accelerator made for individuals who have lost the ability to use their right foot. Mistaking the accelerator pedal for the brake

Photo of handicapped-accessible brake and accelerator pedals. Photo courtesy of Kentucky OSHA.

The KY FACE program investigator evaluated the incident and produced the report "Auto Technician Mistakes Handicapped Accessible Accelerator Pedal for Brake Pedal and Fatally Pins Co-Worker". The report identified two key recommendations to prevent future incidents from occurring: (1) removal of handicapped-accessible equipment prior to operation; and (2) moving office spaces away from car servicing areas.

The FACE report was emailed to 45 car dealerships in Kentucky and 11 handicapped-accessible gas pedal manufacturers. Based on the report, Veigel North America LLC Mobility Products & Design redesigned their Left Foot Accelerator, Model 3545, to retrofit a vehicle's steering column with a key switch. When starting a vehicle with the redesigned pedal, the system defaults to a standard, factory pedal. To activate the left accelerator pedal, a driver must turn the key switch on and press the accelerator function switch to the left. This modification eliminates the need to remove the pedal for servicing and prevents unintended drivers from using the left foot accelerator.⁵ The redesigned pedal was introduced at the National Mobility Equipment Dealers Conference in February 2015 and is anticipated to be available to the public in June 2015.
