Personal Protective Equipment Conformity Assessment Studies and Evaluations

Evaluation of Six Self-Contained Breathing Apparatus for Potential Contribution to a Fatal Event in the Fire Service

Wilmington Delaware Fire Department Request for five MSA Model Firehawk[®] M7 and one MSA Model G1 units

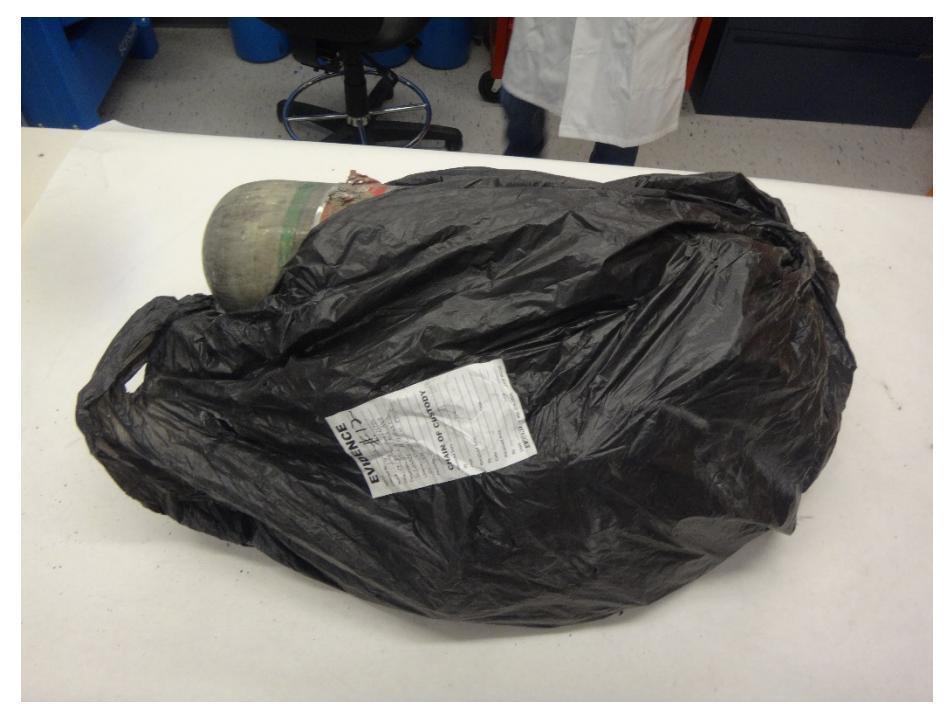
As received (pictured below) SCBA unit #12

- SCBA unit #12 was hand delivered to Lab H1513 by NIOSH DSR investigators
- Cylinder was received empty and closed
- Bypass was open
- Mask-mounted regulator (MMR) was connected to facepiece

SCBA unit #12 facepiece, and cylinder as received

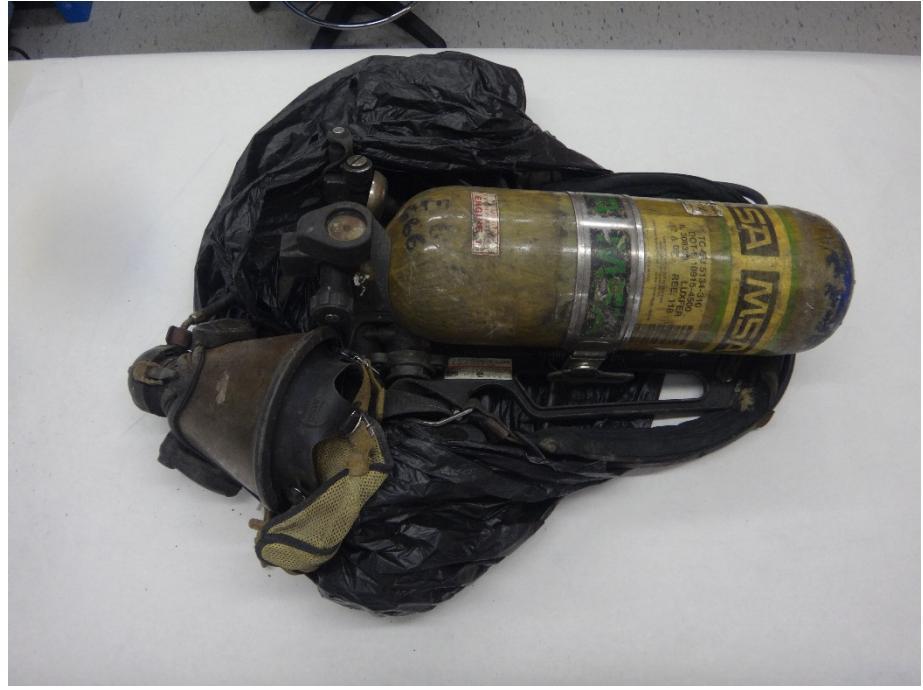
As received (pictured below) SCBA unit #13

- SCBA unit #13 was hand delivered in a black trash bag to Lab H1513 by NIOSH DSR investigators
- Cylinder received with 1500 psi and bypass closed
- Cylinder was not completely threaded to the cylinder attachment
- Mask-mounted regulator (MMR) was connected to facepiece
- Facepiece was included and regulator housing was attached to mask

SCBA unit #13 facepiece and cylinder as received

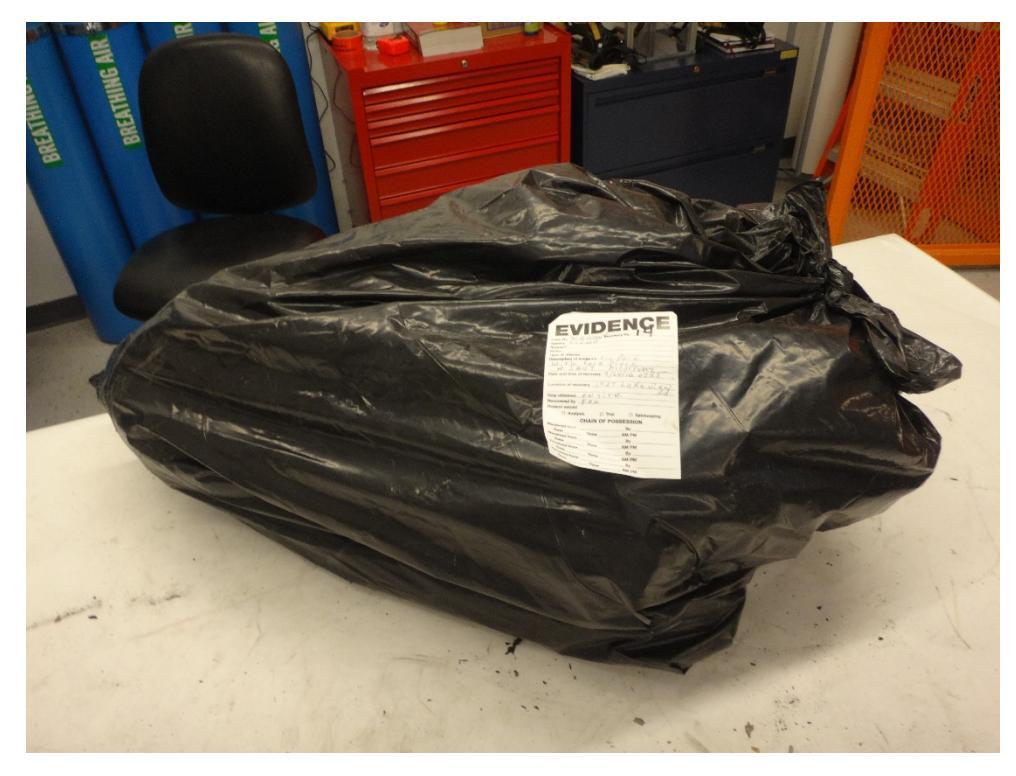
As received (pictured below) SCBA unit #14

- SCBA unit #14 was hand delivered in a black trash bag to Lab H1513 by NIOSH DSR investigators
- Attached to bag was an evidence tag with #14 written on it
- Cylinder included was empty with valve open
- Bypass was closed
- Cylinder was completely threaded to the cylinder attachment
- Facepiece was included with mask-mounted regulator (MMR) housing attached to mask

SCBA unit #14 facepiece, and cylinder as received

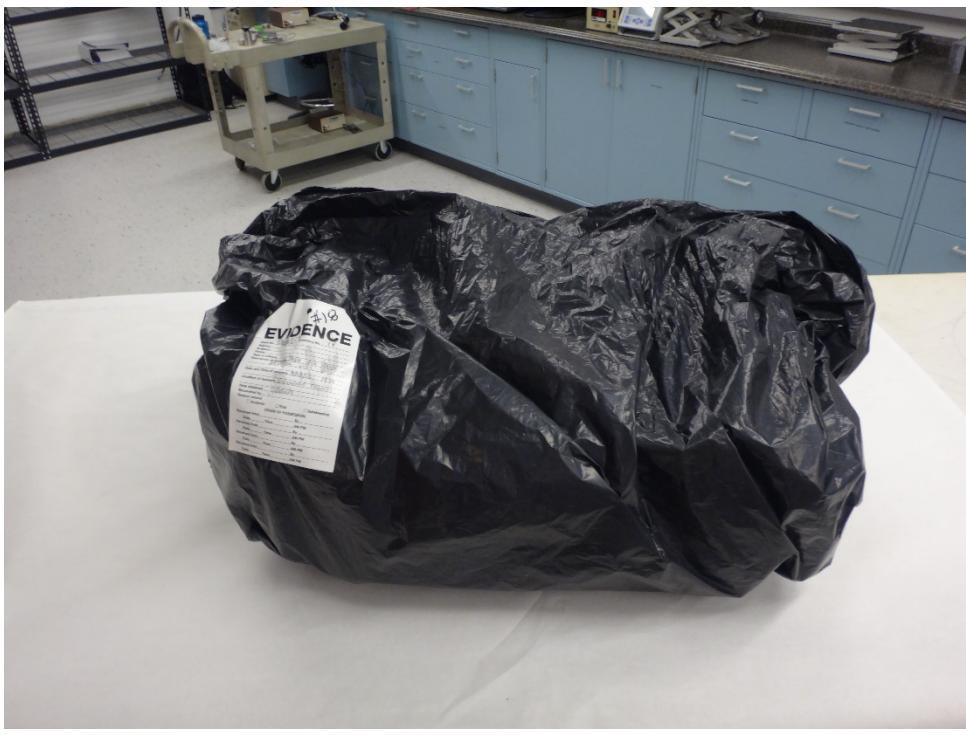
As received (pictured below) SCBA unit #18

- SCBA unit #18 was hand delivered in a black trash bag to Lab H1513 by NIOSH DSR investigators
- Attached to bag was an evidence tag with #18 written on it
- Cylinder included was empty with valve closed
- Bypass was closed
- Facepiece was included with mask-mounted regulator (MMR) housing attached to mask

SCBA unit #18 facepiece, and cylinder as received

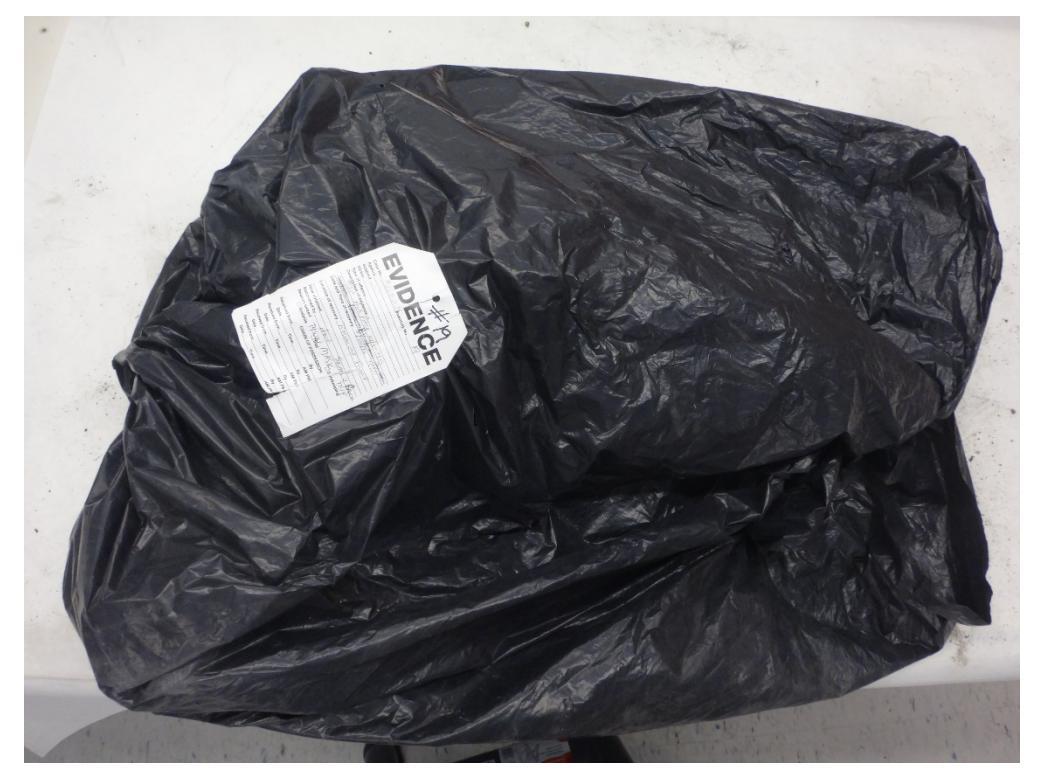
As received (pictured below) SCBA unit #19

- SCBA unit #19 was hand delivered in a black trash bag to Lab H1513 by NIOSH DSR investigators
- Cylinder was included with 2000 psi of air with valve closed
- Bypass was closed
- Cylinder was not completely threaded to the cylinder attachment
- Facepiece was included with mask-mounted regulator (MMR) locked into mask

SCBA unit #19 facepiece, and cylinder as received

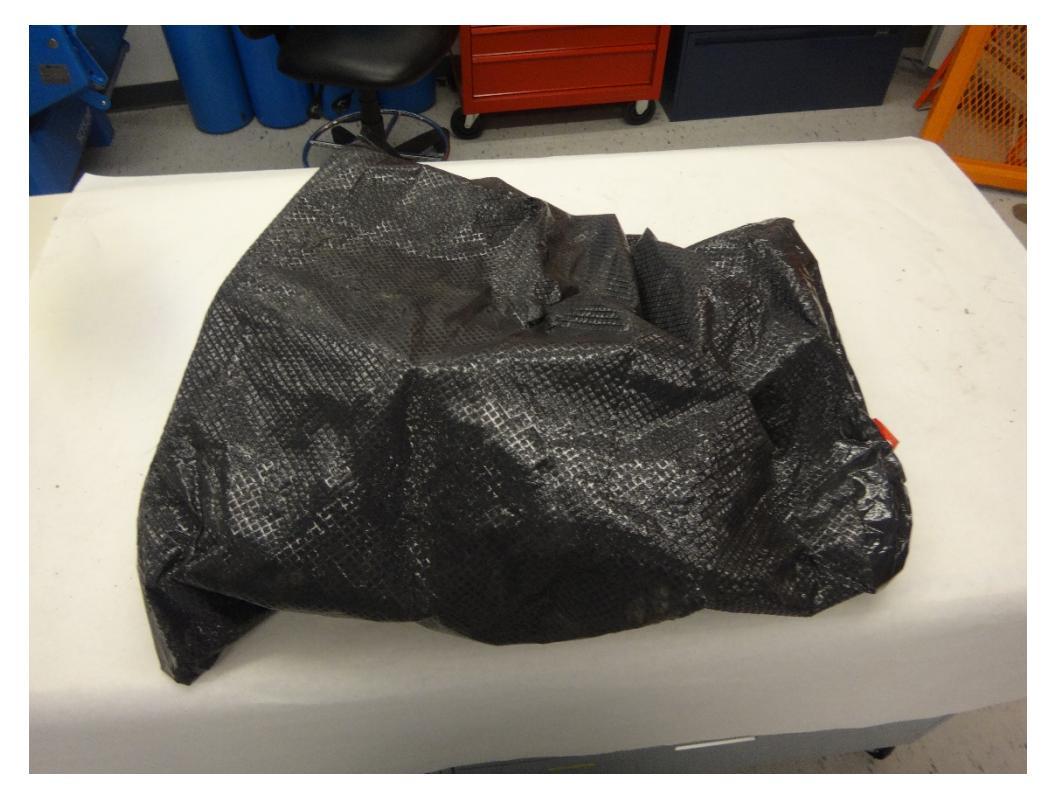
As received (pictured below) SCBA unit #Unknown

- SCBA unit #Unknown was hand delivered in black trash bag to Lab H1513 by NIOSH DSR investigators
- No evidence tag attached to it
- Cylinder was included with 3500 psi of air
- Bypass was closed
- Facepiece was included with mask-mounted regulator (MMR) locked into mask

SCBA unit #Unknown facepiece, and cylinder as received

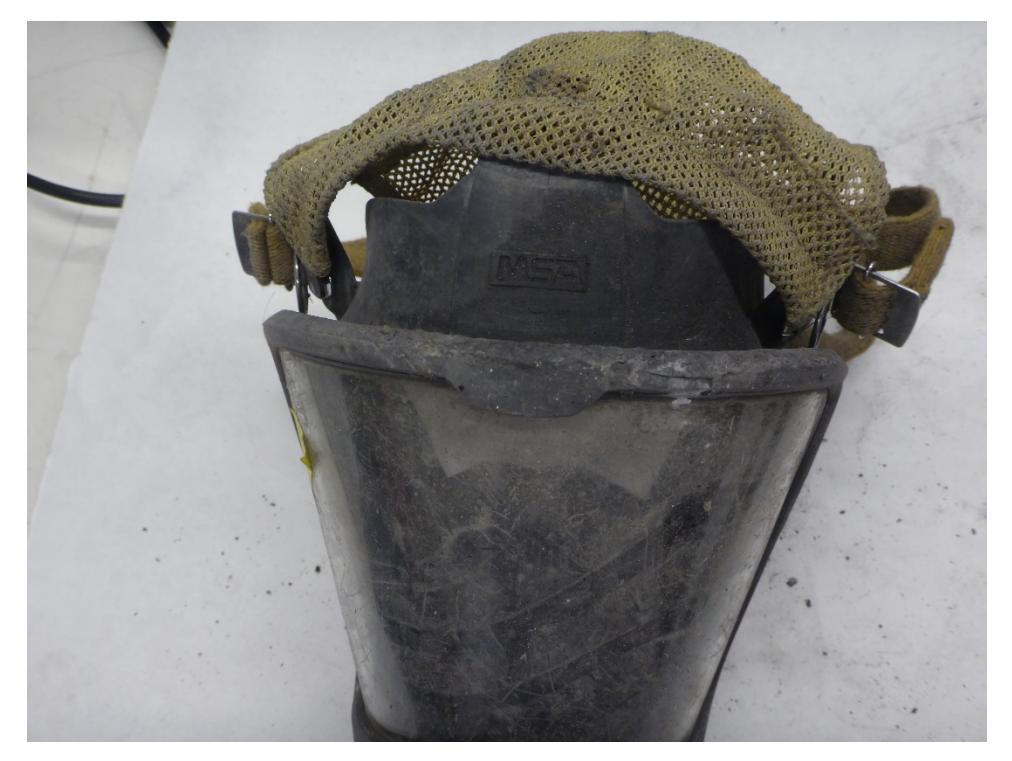
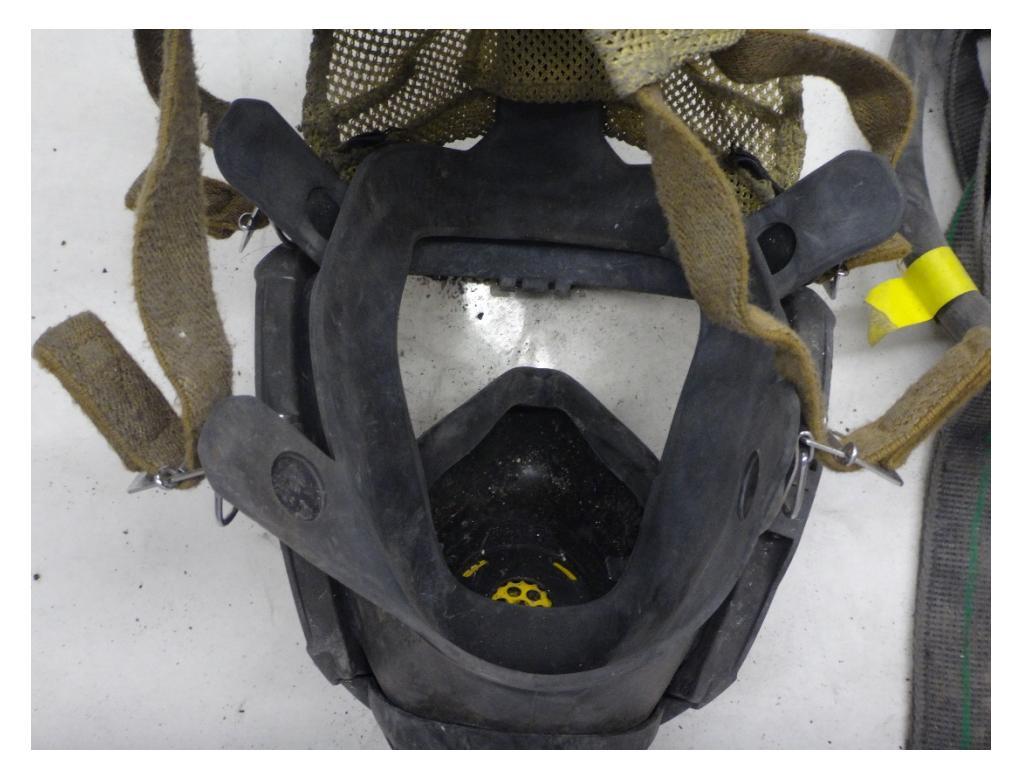
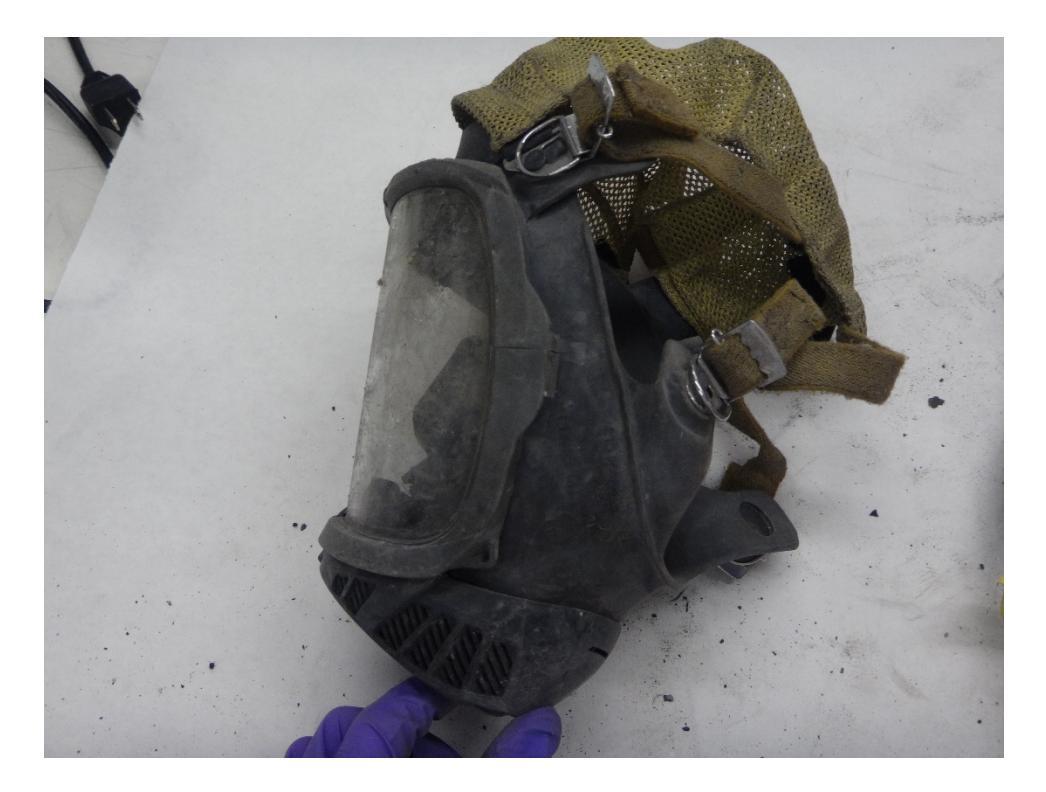
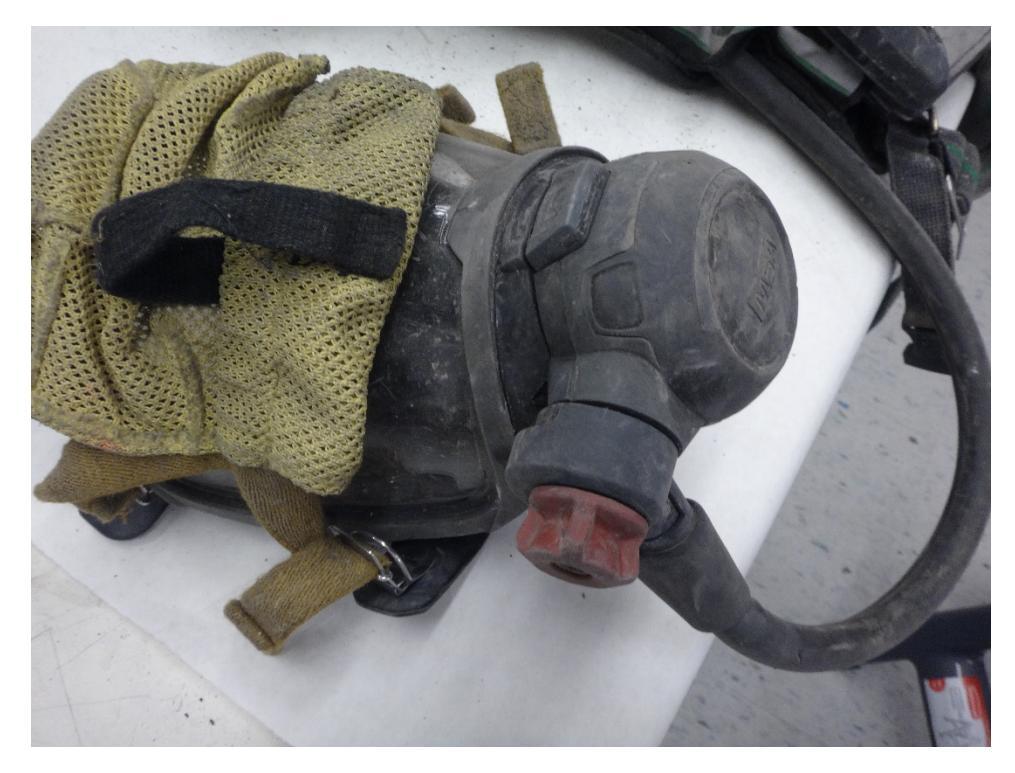
- Facepiece rim assembly 10156459; M/N: MSA G1
- Facepiece seal P/N: 10144167; M/N: 7-2774-1: MFG date: 8/14
- Nosecup P/N: 10144170; M/N: 7-2774-1; MFG date: 7/14
- Overall condition: fair, dirty with scratches
- Lens was scratched and dirty. Upper lens ring was slightly melted
- Lens retaining ring was intact
- MMR housing was clean and in good condition
- HUD was present and intact
- Communication device was present and in good condition
- Hairnet was in good condition. All straps and buckles functioned properly.

Figure 2: Top view of facepiece

Figure 3: Facepiece hairnet and straps

Figure 4: Side view of facepiece, skirt, and nosecup

Figure 5: MMR attached to facepiece

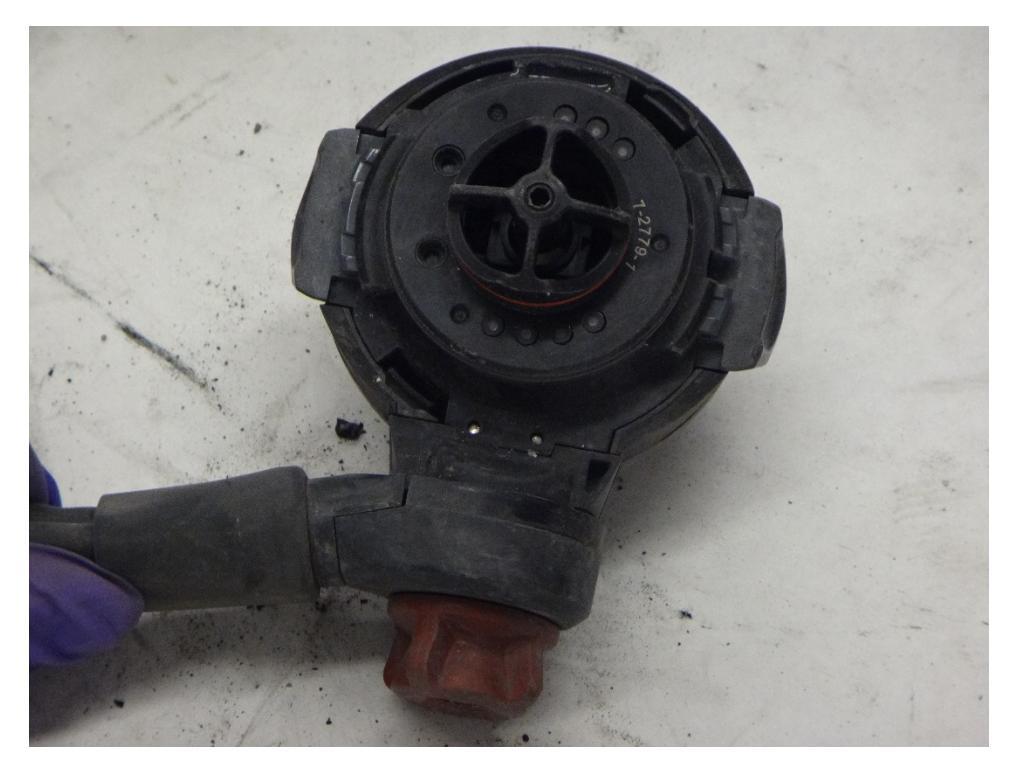
Figure 6: MMR with identifying markings

- MMR label on front: MSA; M/N: 7-2779-1
- Overall condition was good
- MMR was secured to low pressure line
- Bypass closed
- Inside flange had normal wear and in good condition
- Sealing area was clean and in good condition
- Regulator could be attached and removed
- Locking assembly functioned

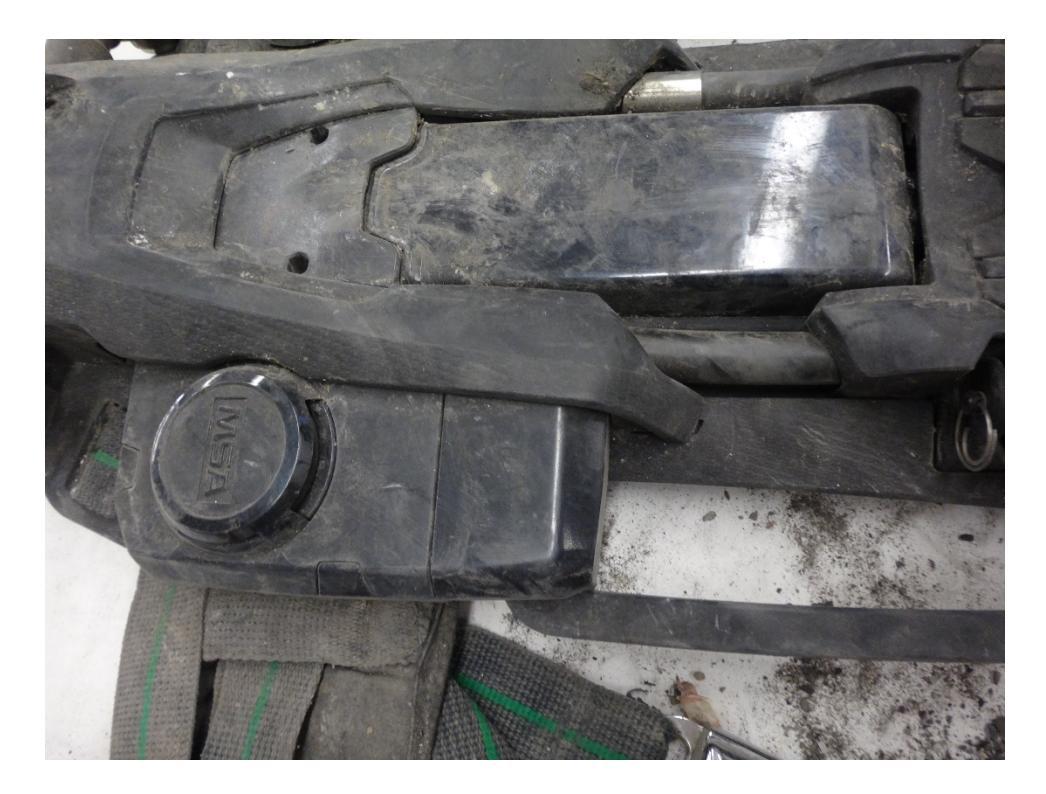
Figure 9: Low pressure hose attachment to SCBA

- Overall condition was good
- All airline connections were secure
- Could not visually inspect due to casing, but all lines going to the pressure reducer were in good condition

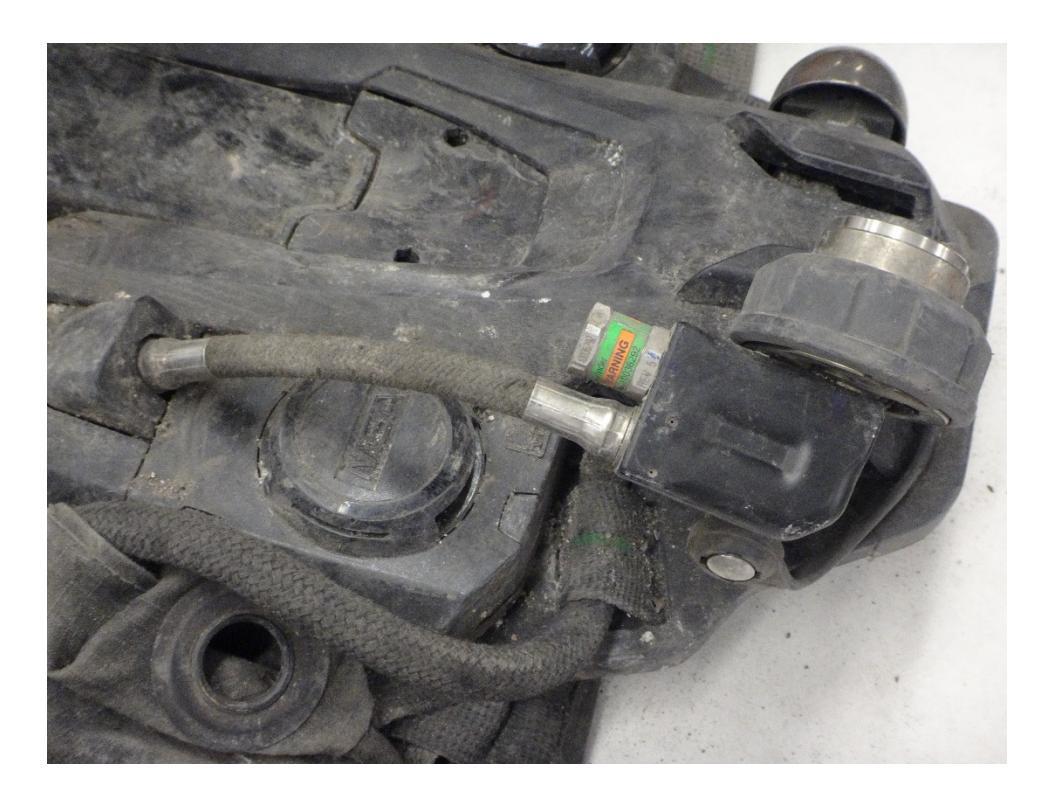
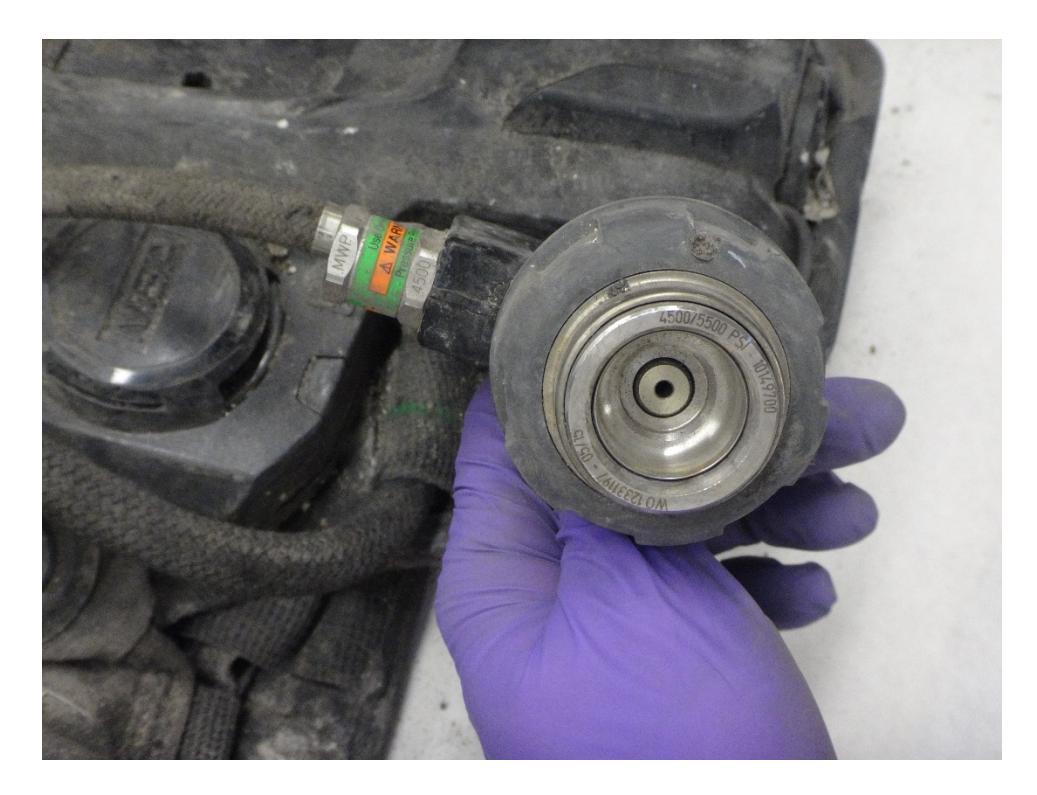
- High pressure S/N: 7-2844-1
- High pressure line was in fair condition, dirty
- Cylinder quick connect attachments were in good condition

Figure 12: High pressure hose and cylinder attachment

Figure 13: Cylinder attachment

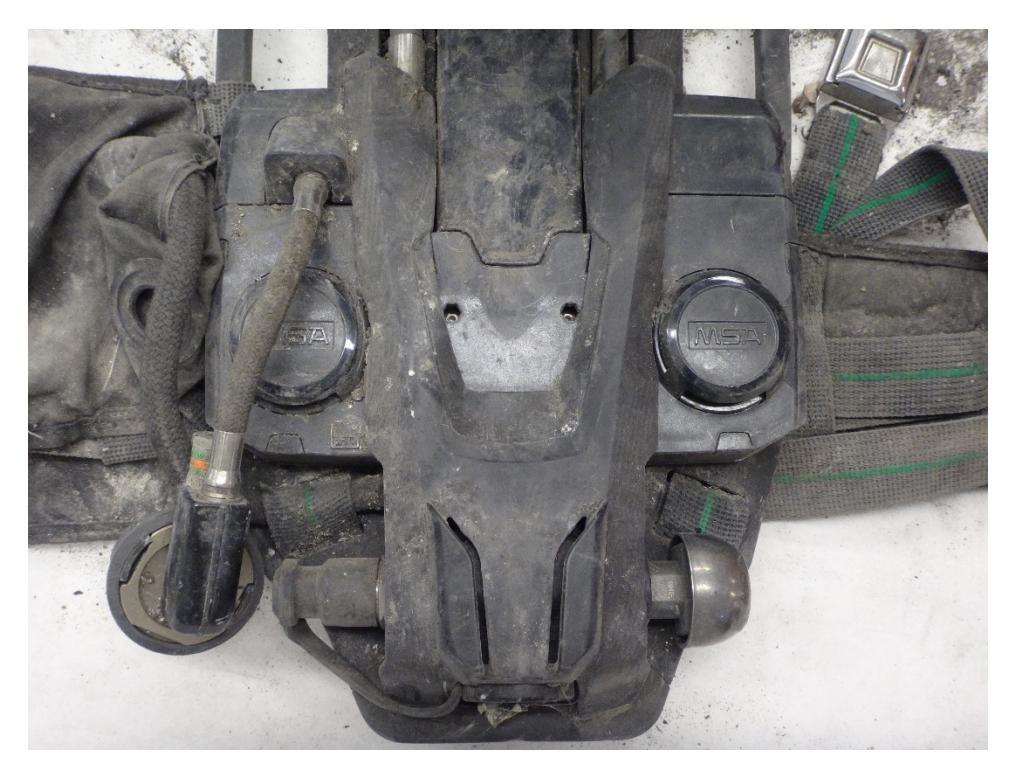
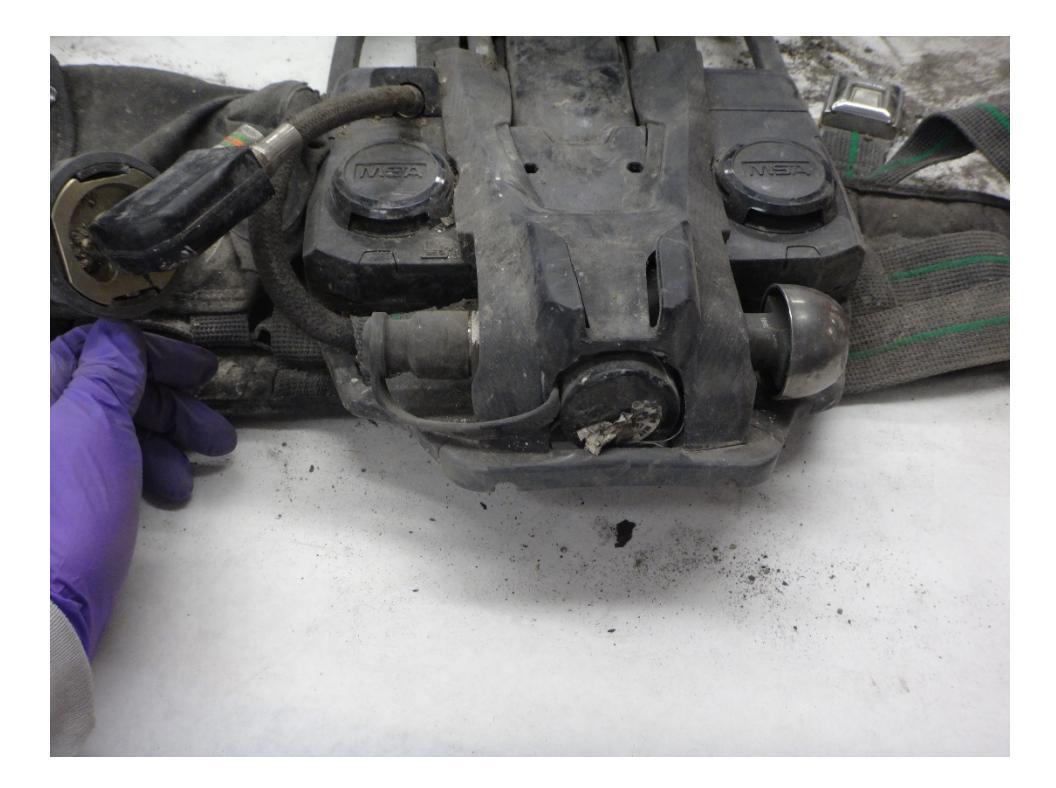
- SEI label:07-2015; P/N 10148687 4500 psi
- PASS met requirements of NFPA 1982: Standard on Personal Alert Safety Systems (PASS) 2013 edition
- FCC ID: P9R-10154953
- Overall condition was good, but very dirty with debris and melted in spots
- Held securely to backframe
- Battery for power module was attached and looked good with debris and small melted spots around it

Figure 14: Top view of power module

Figure 15: Bottom view of power module

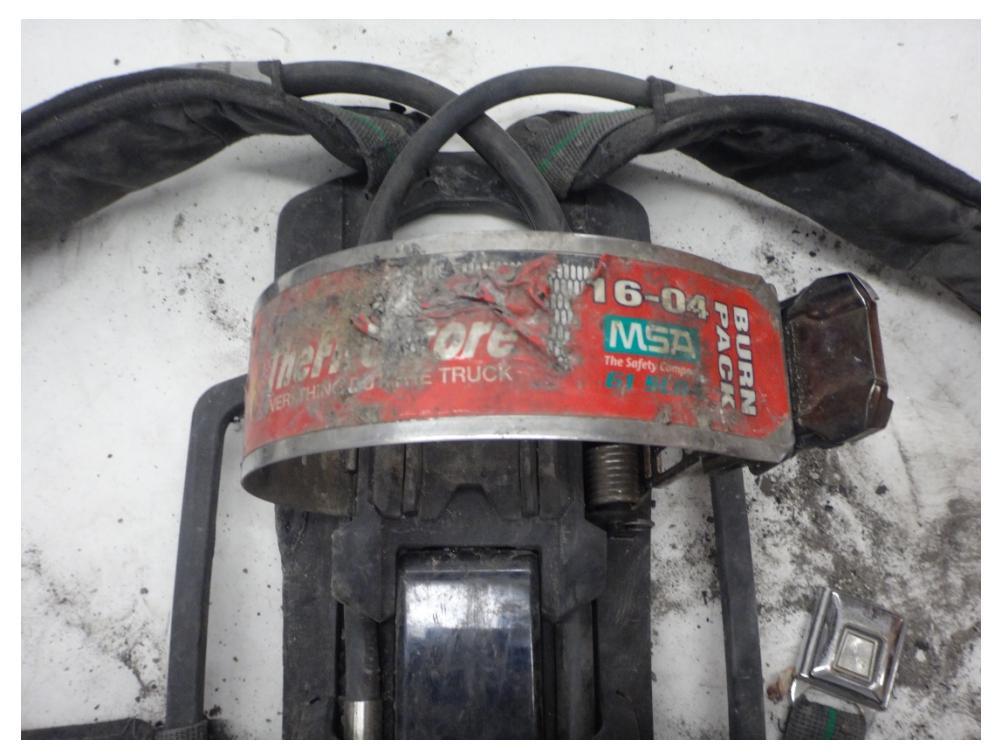
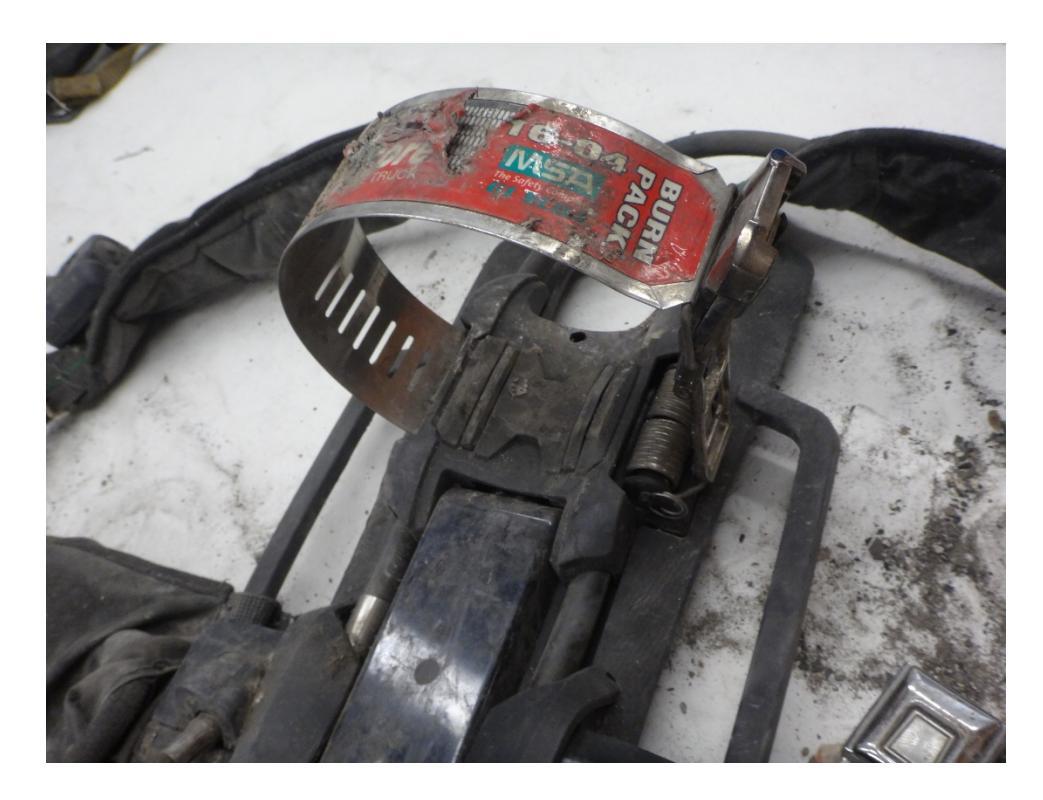
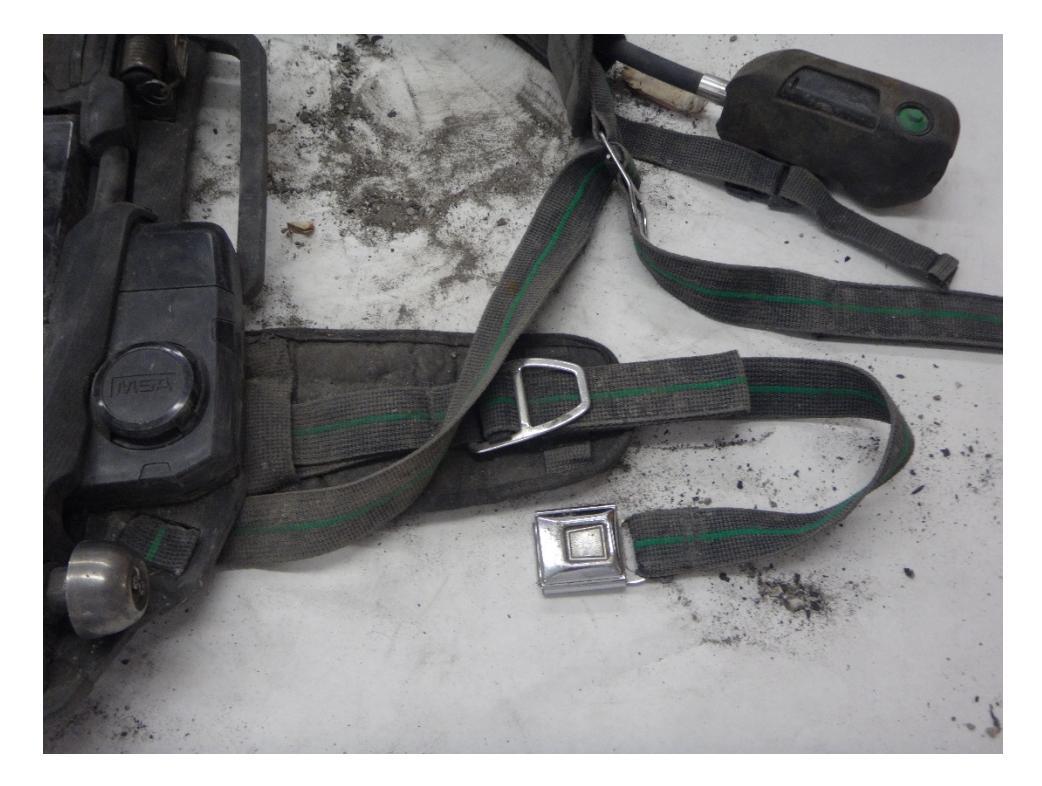
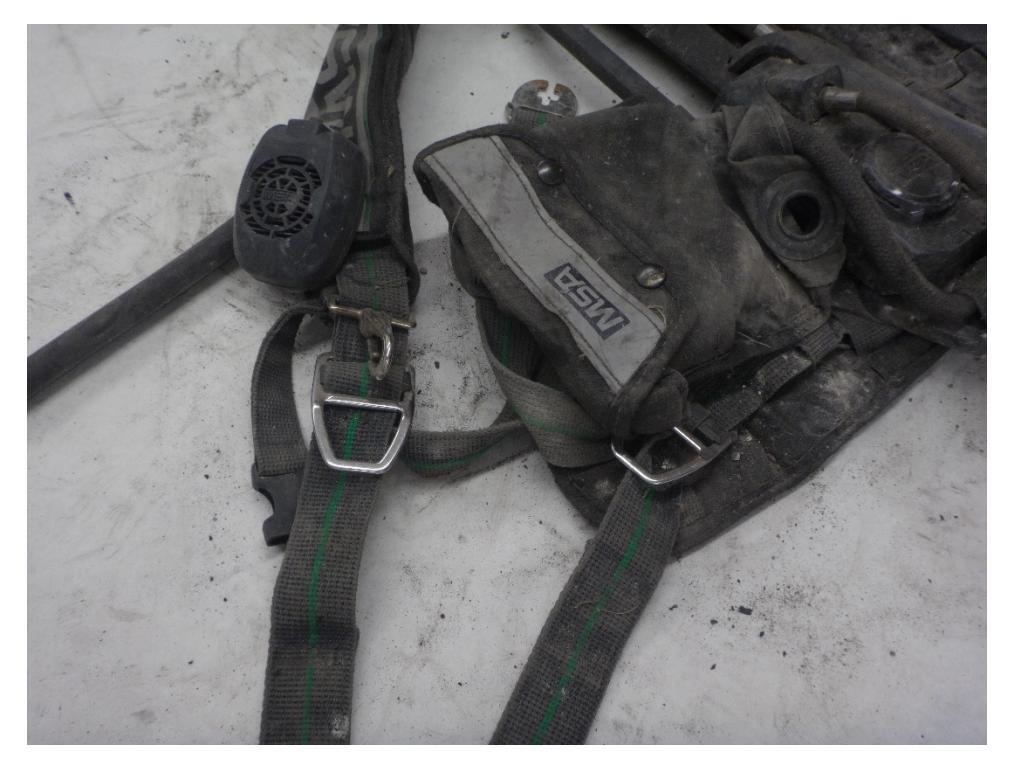
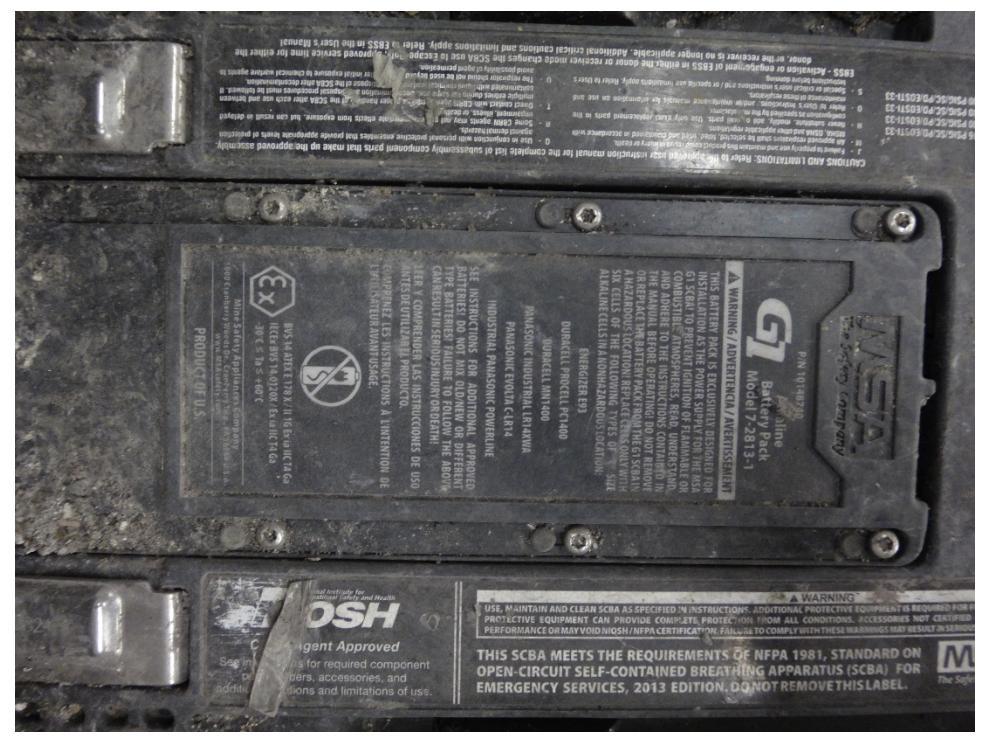
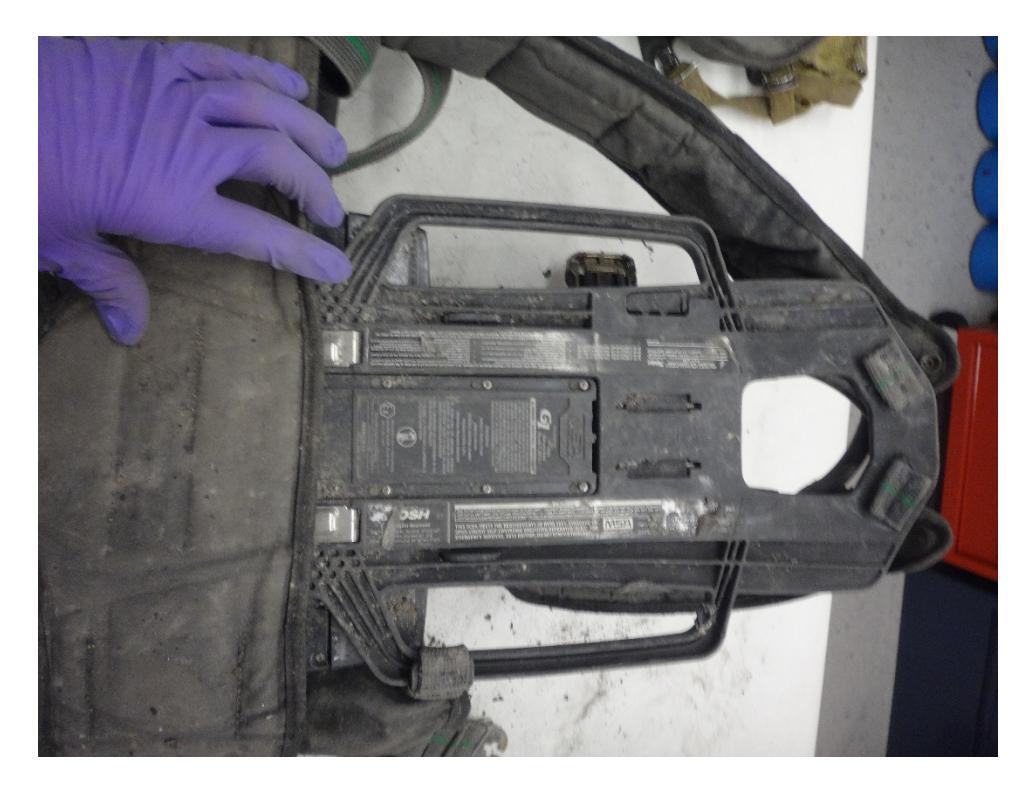
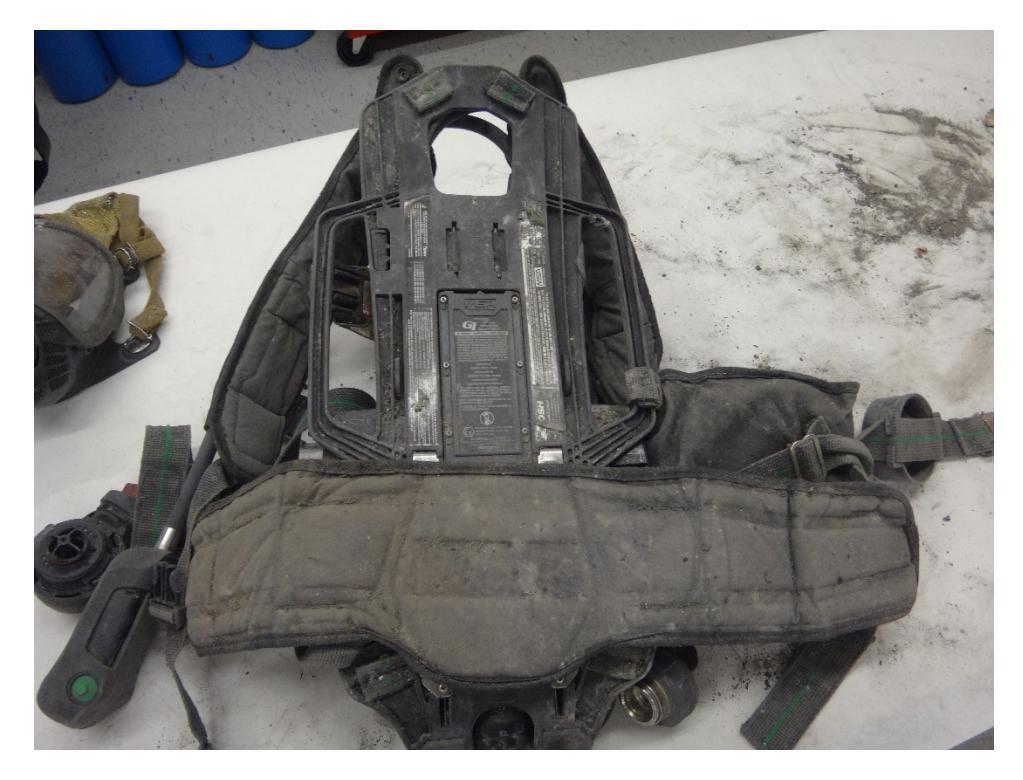
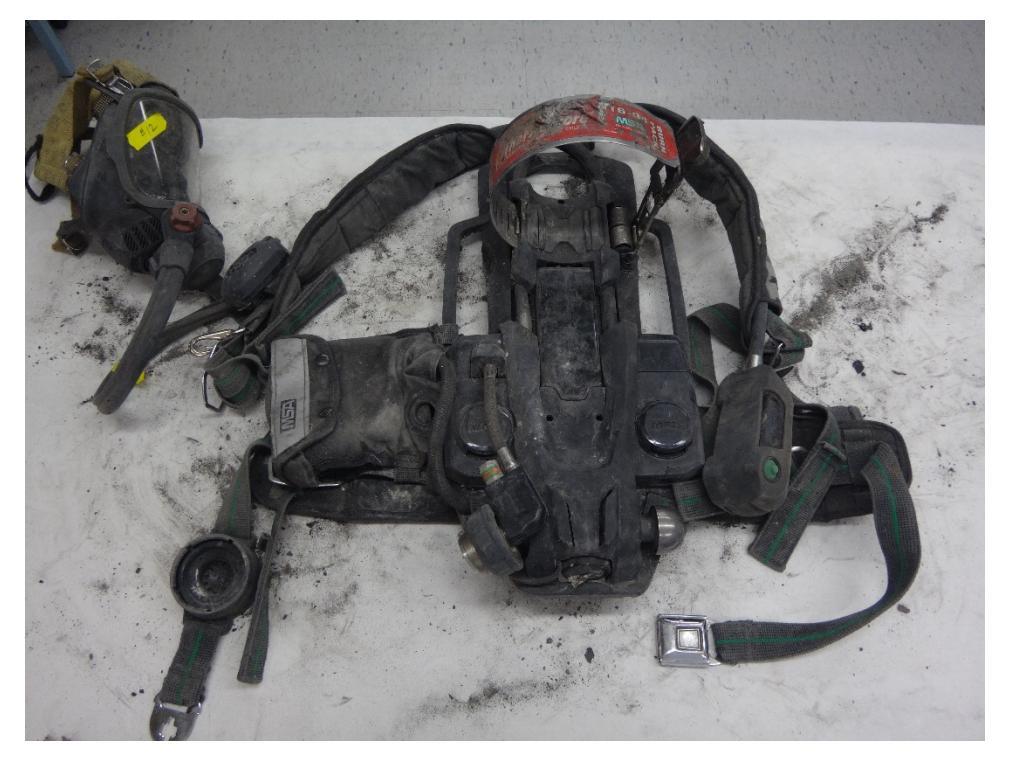
Straps and Buckles (Figure 18 -26)

- Overall condition of straps was good, but dirty
- Hose lines passed through shoulder straps
- All adjustable buckles moved and held in place
- Waist area buckle latched

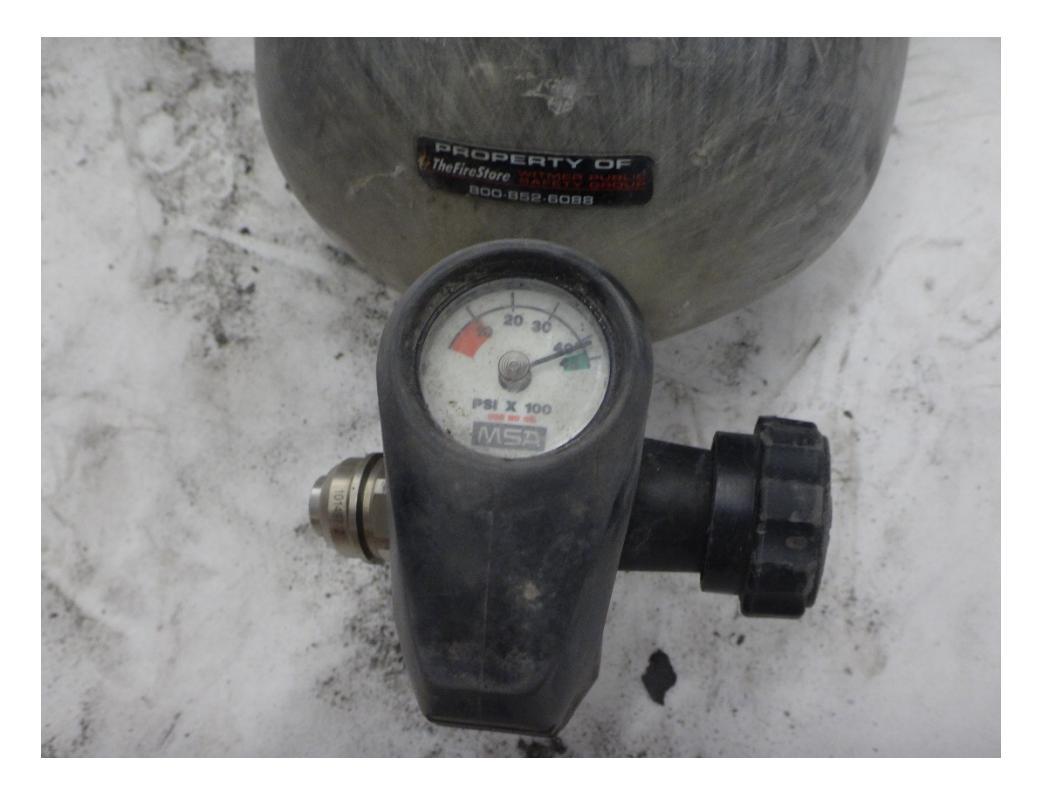
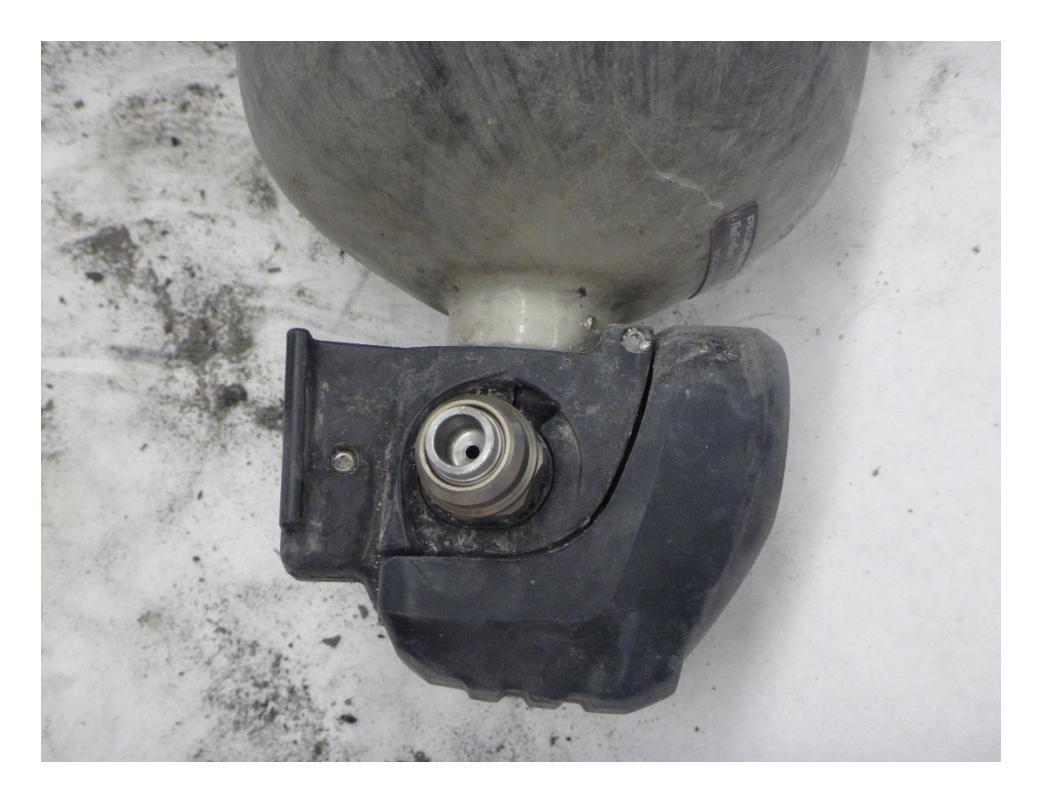
- DOT-SP 10915-4500; TC-SU-5134-310; ACU106039
- Luxfer P/N: L65G-98; REE 125
- Hydrostatic date: 10/2014; 45 minute, 4500 PSI
- Marking on stem: 804722-BC0318
- Overall condition was good, but really dirty; some surface scratches
- Gauge was readable
- Threads were good; attached to the threads was the male quick connect
- O-ring was present and in good condition
- Rubber bumper at base of cylinder valve was in good condition
- Sticker on cylinder: property of "The Fire Store" Witmer Public Safety Group

Figure 27: Cylinder gauge

Figure 28: Cylinder assembly and quick connect adapter

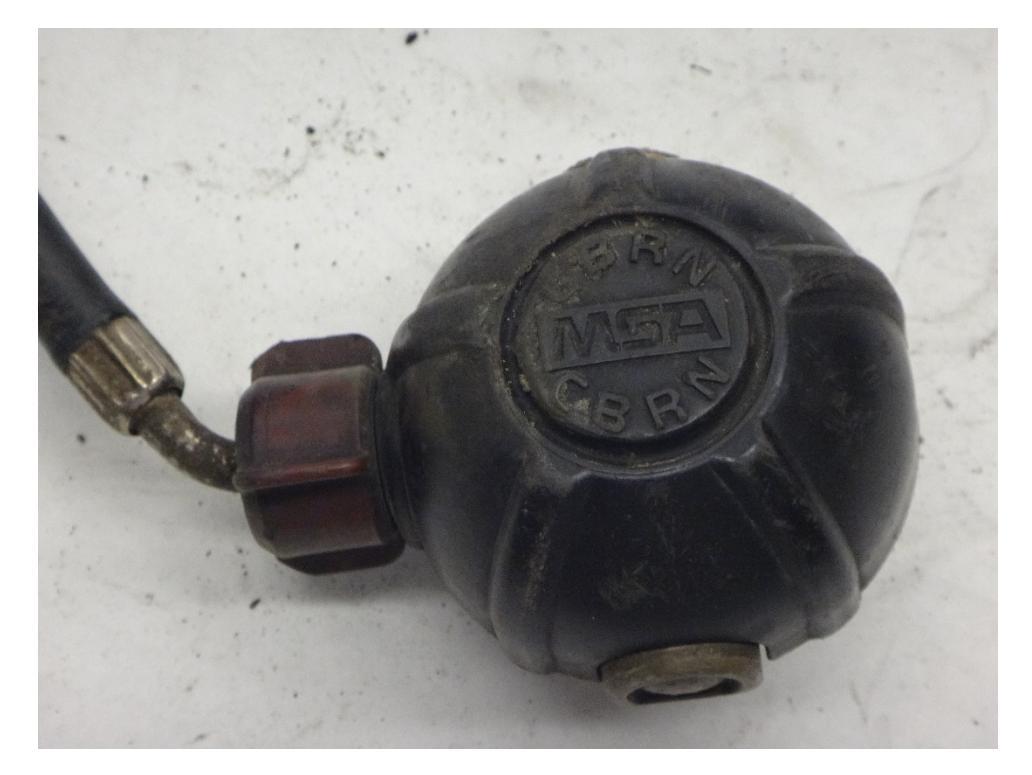
Figure 35: Top view of MMR
