Personal Protective Equipment Conformity Assessment Studies and Evaluations

Evaluation of Six Self-Contained Breathing Apparatus for Potential Contribution to a Fatal Event in the Fire Service

Wilmington Delaware Fire Department Request for five MSA Model Firehawk[®] M7 and one MSA Model G1 units

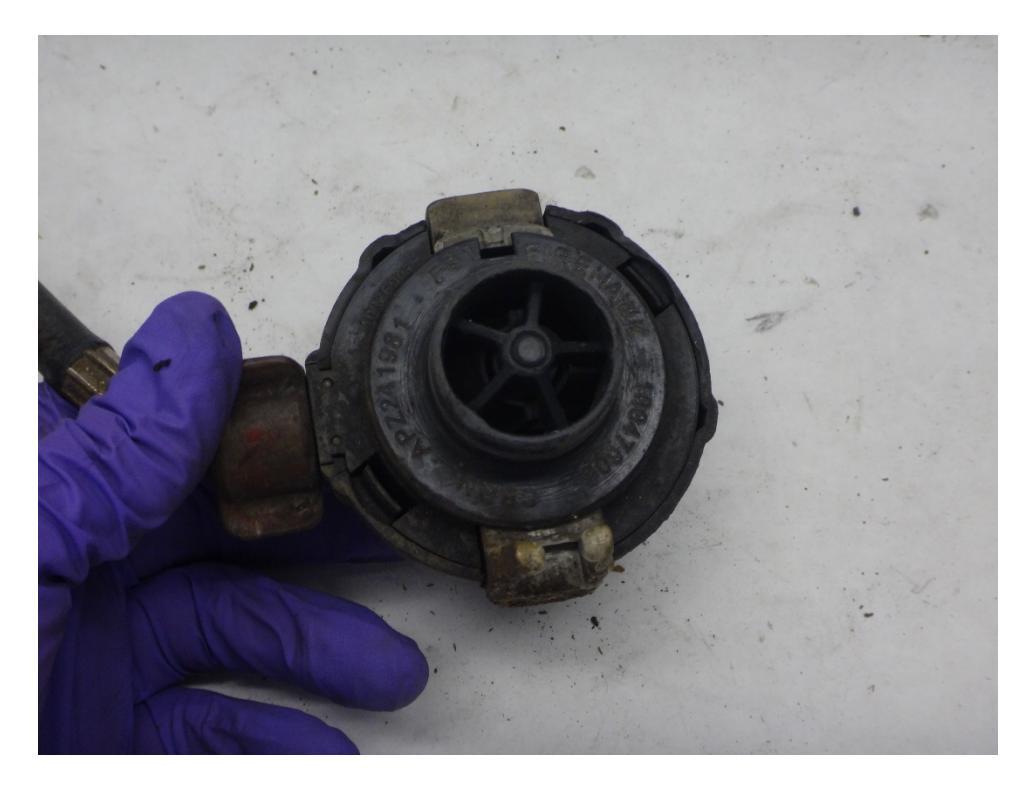
Figure 36: Inside flange of MMR

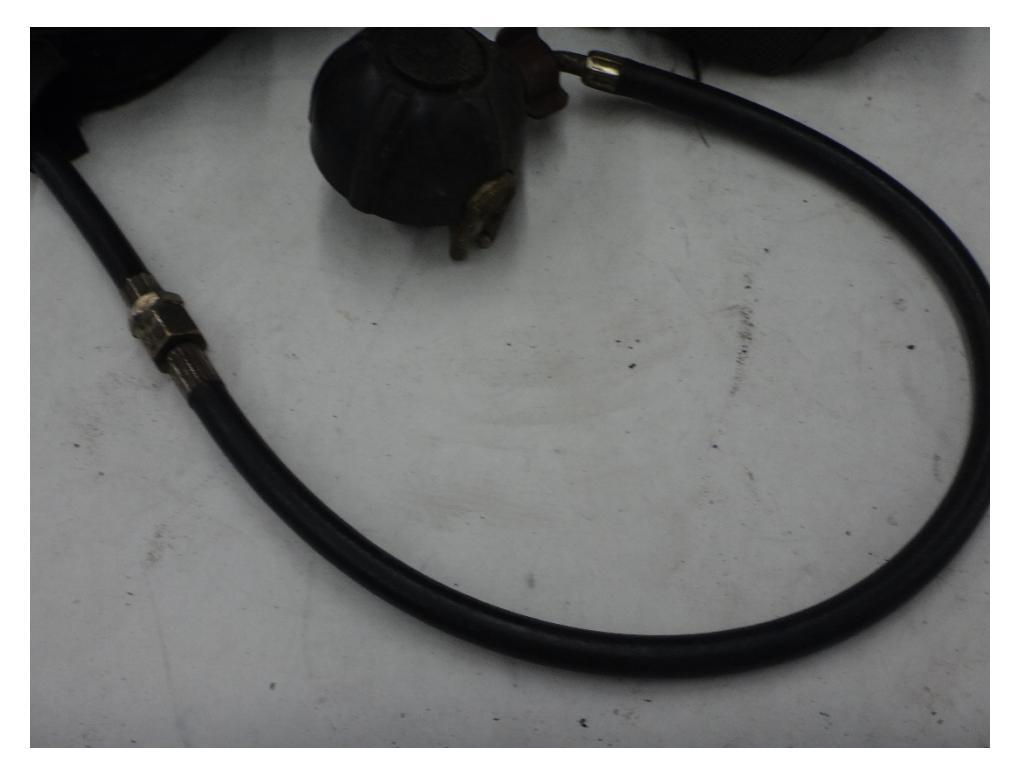
Figure 37: Low pressure line and MMR

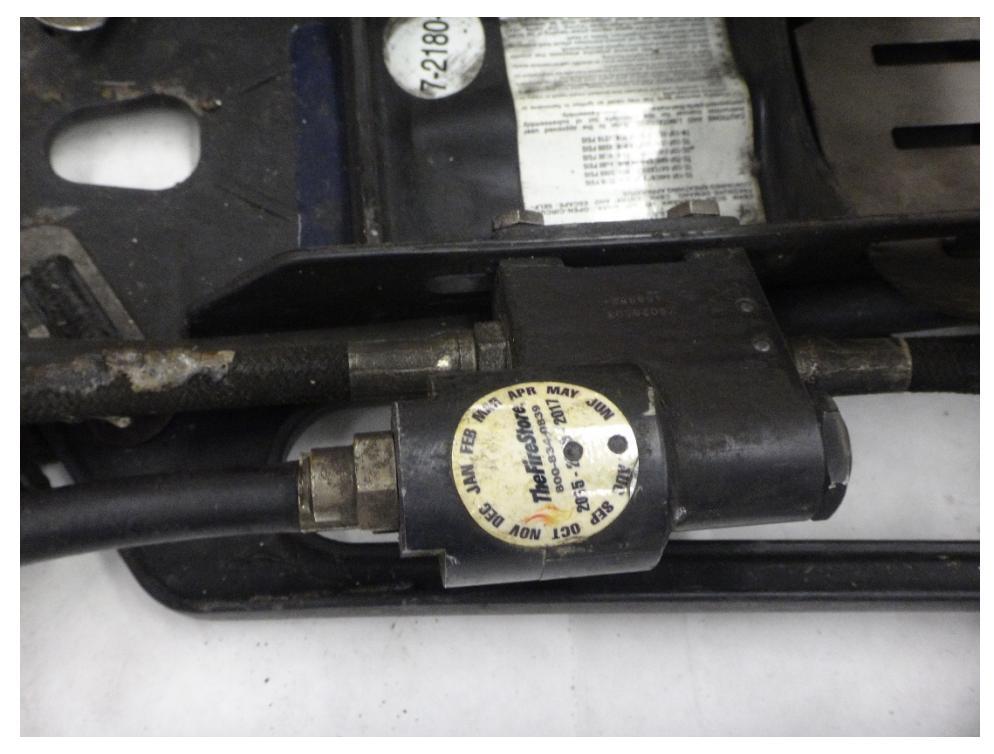
Figure 38: Inside view of pressure reducer assembly with "The Fire Store" Sticker

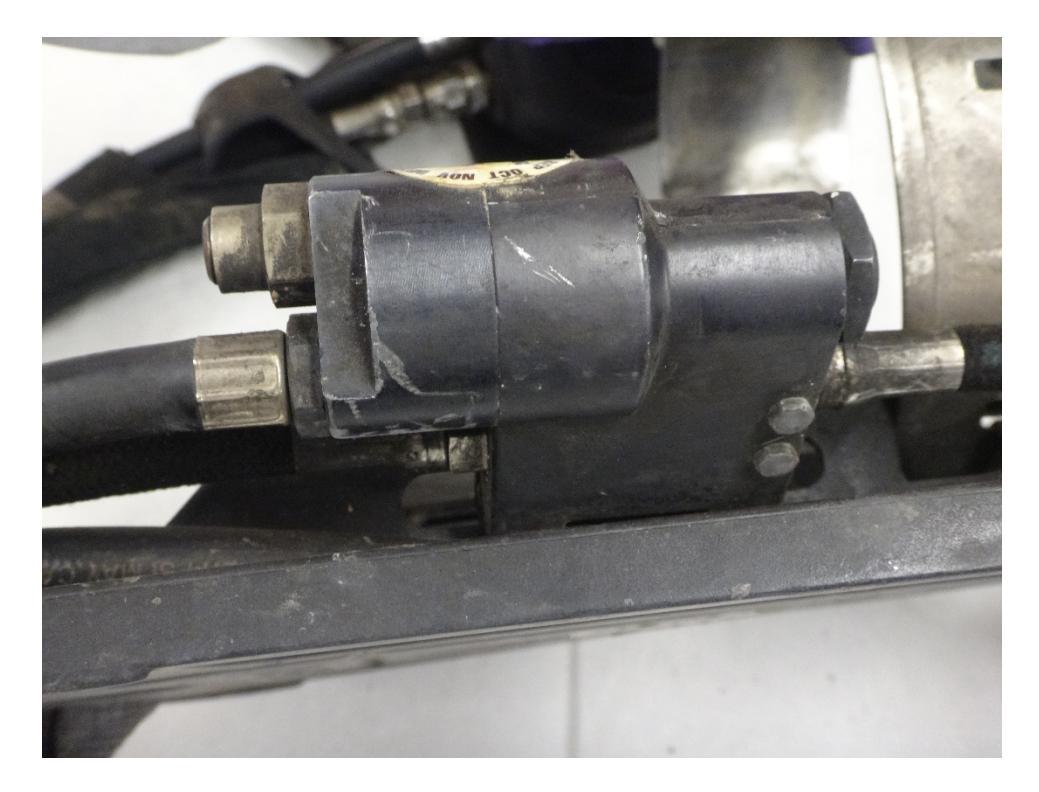
Figure 39: Bottom view of pressure reducer assembly

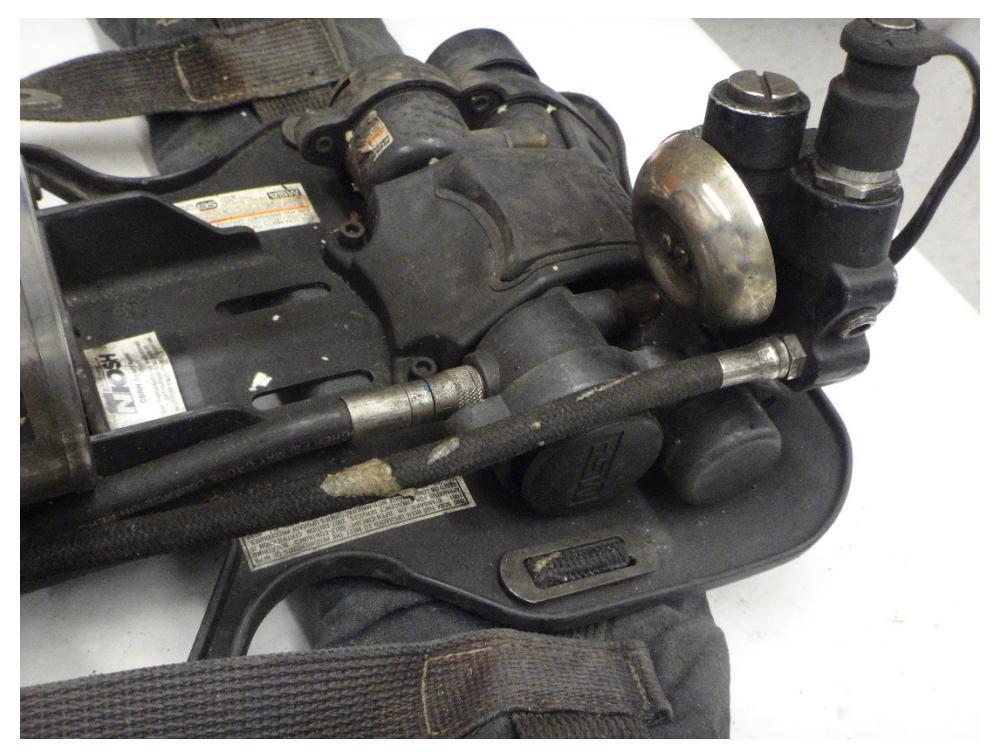
Figure 40: High pressure hose and cylinder attachment

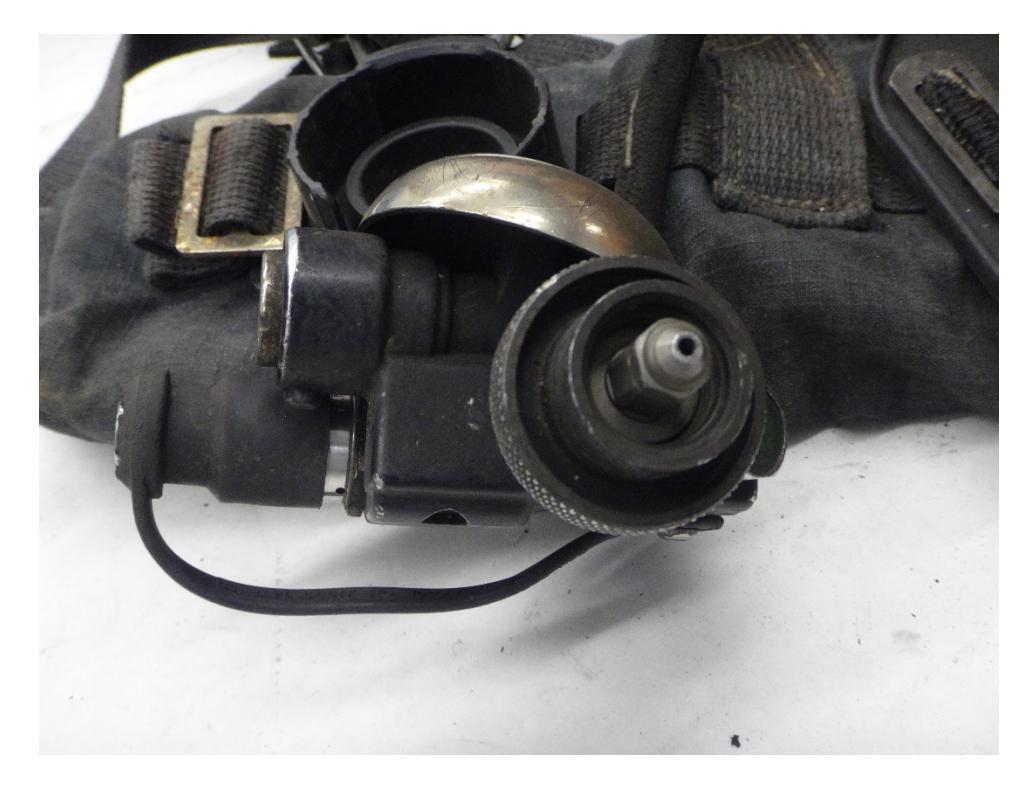
Figure 41: Cylinder attachment threads

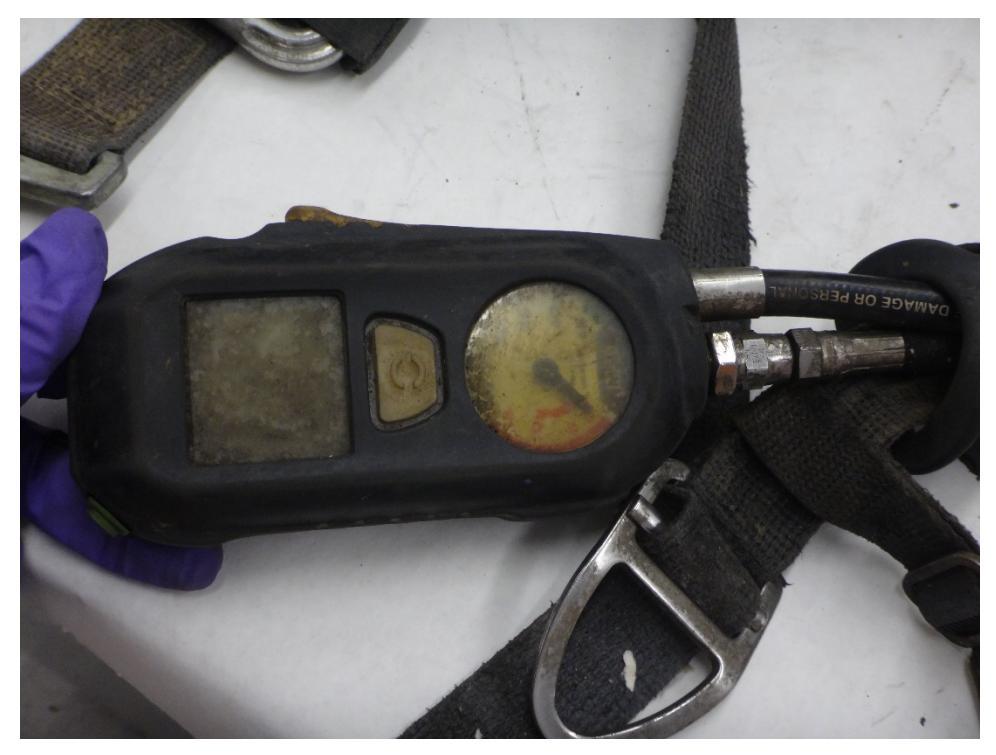
Figure 44: PASS control console

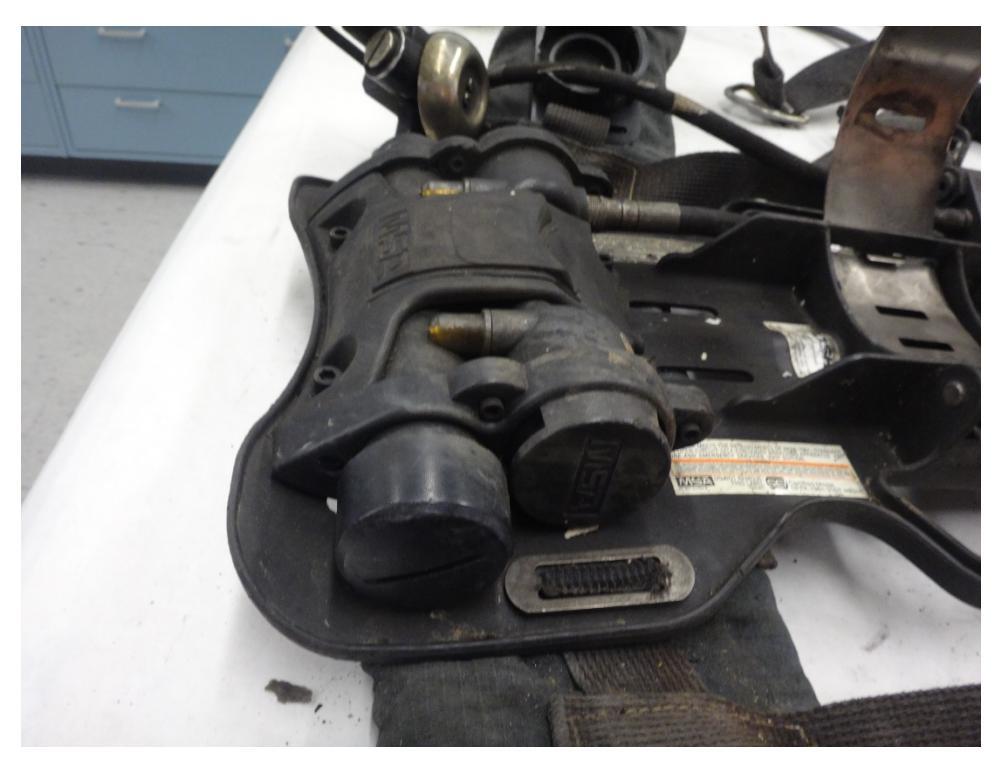
Figure 47: Side view of control module

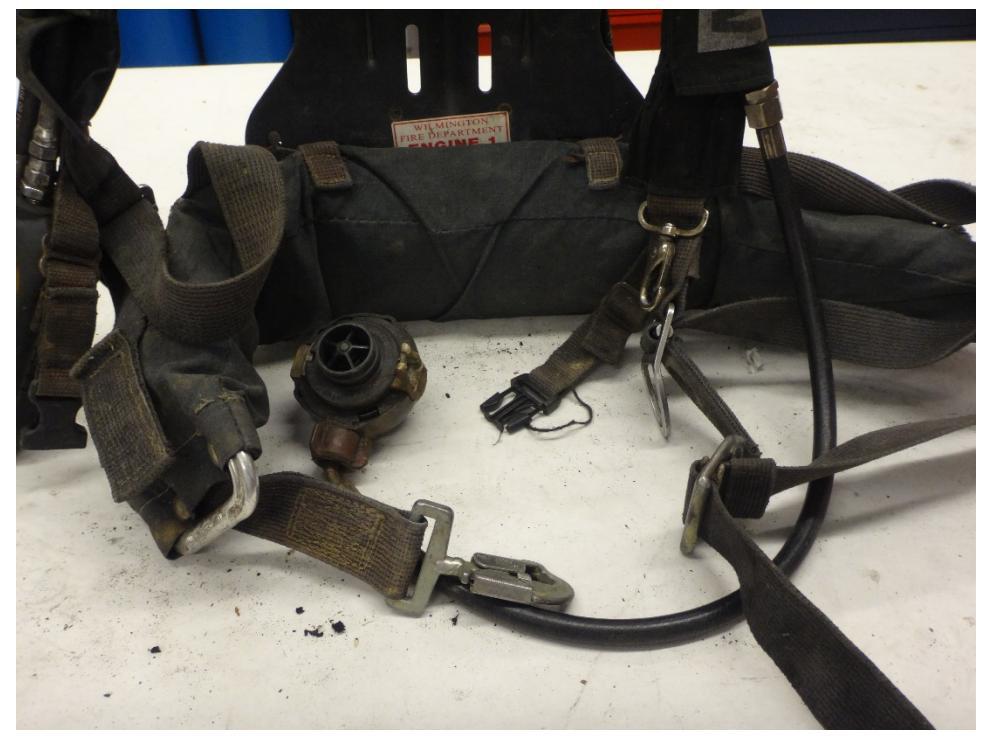
Figure 51: Top view of waist belt

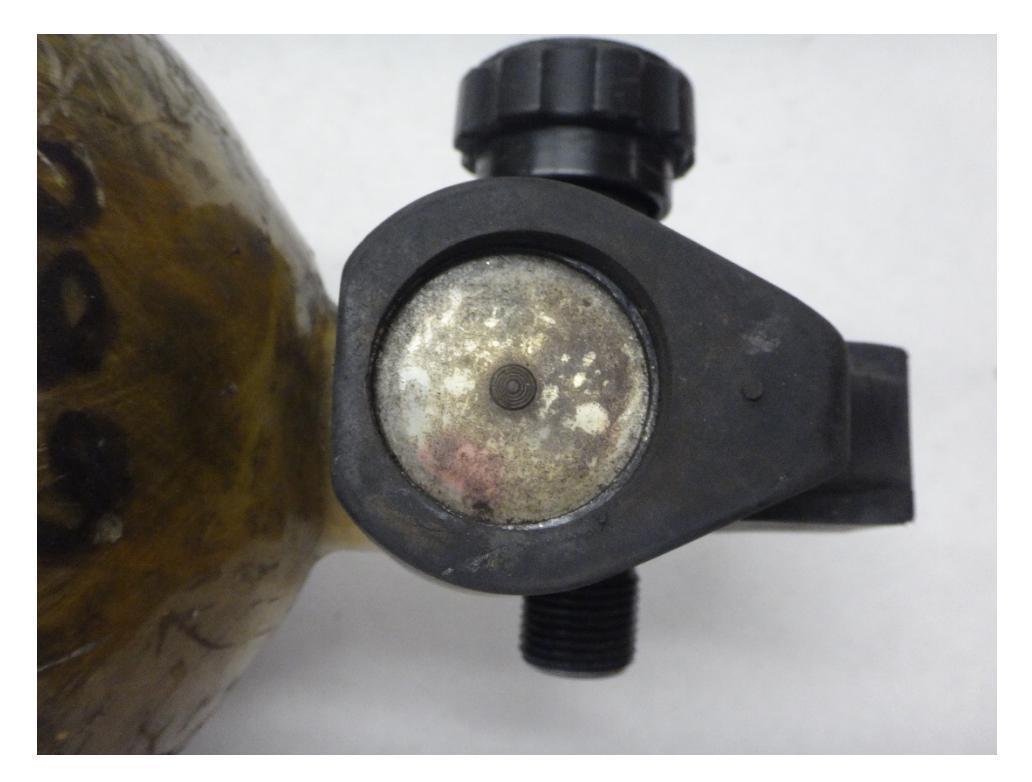
Figure 53: Cylinder gauge

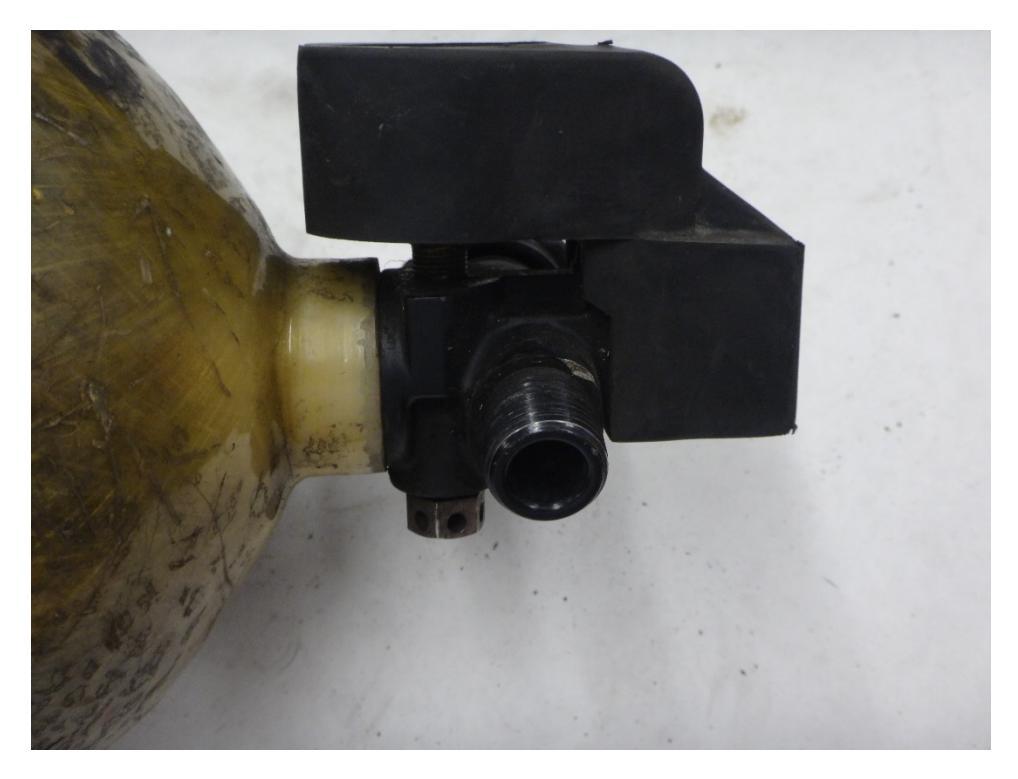
Figure 54: View of cylinder threads

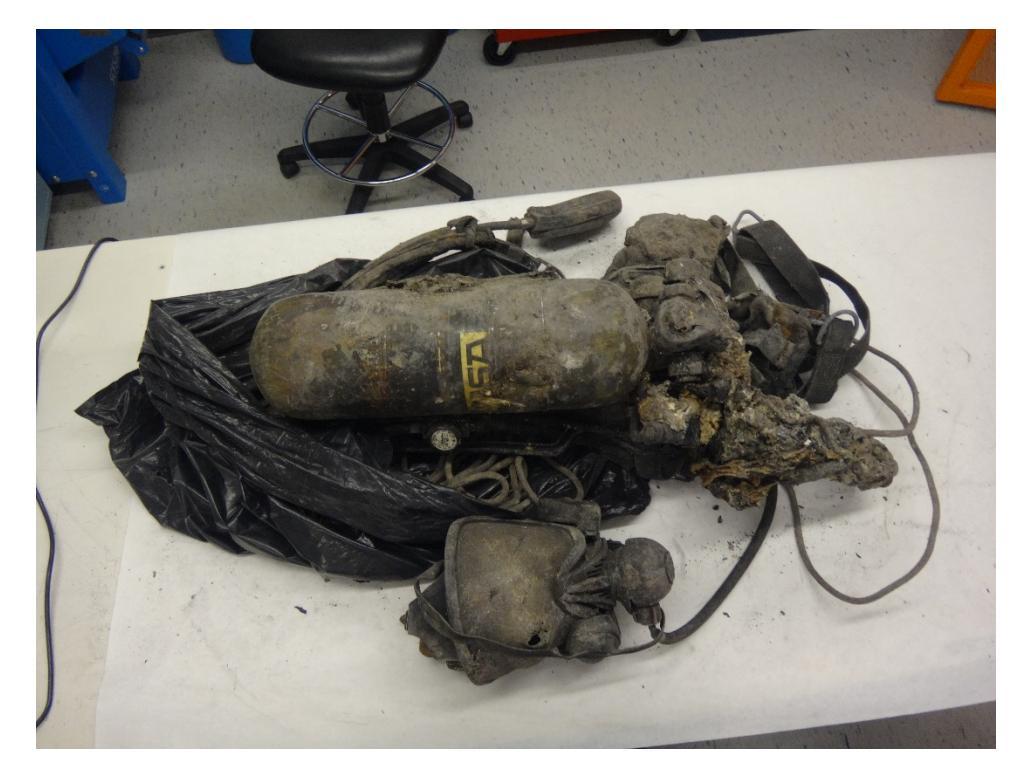
Figure 57: All components of SCBA unit #14 to be examined

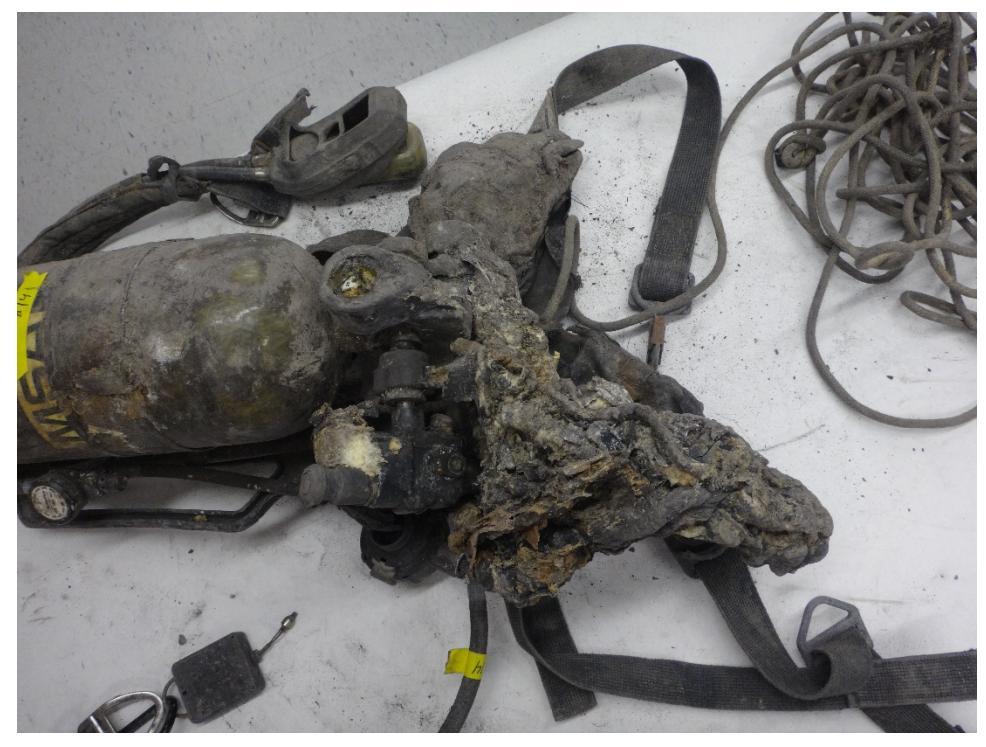
Figure 637: Debris melted to bottom of unit

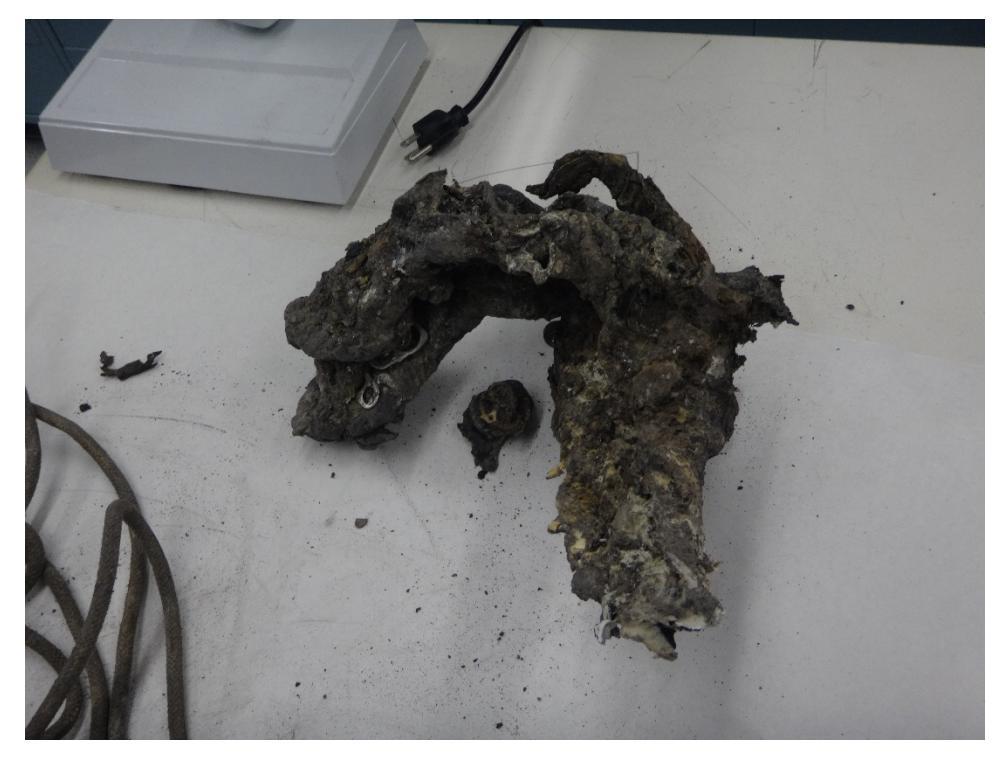
Figure 648: Melted debris removed

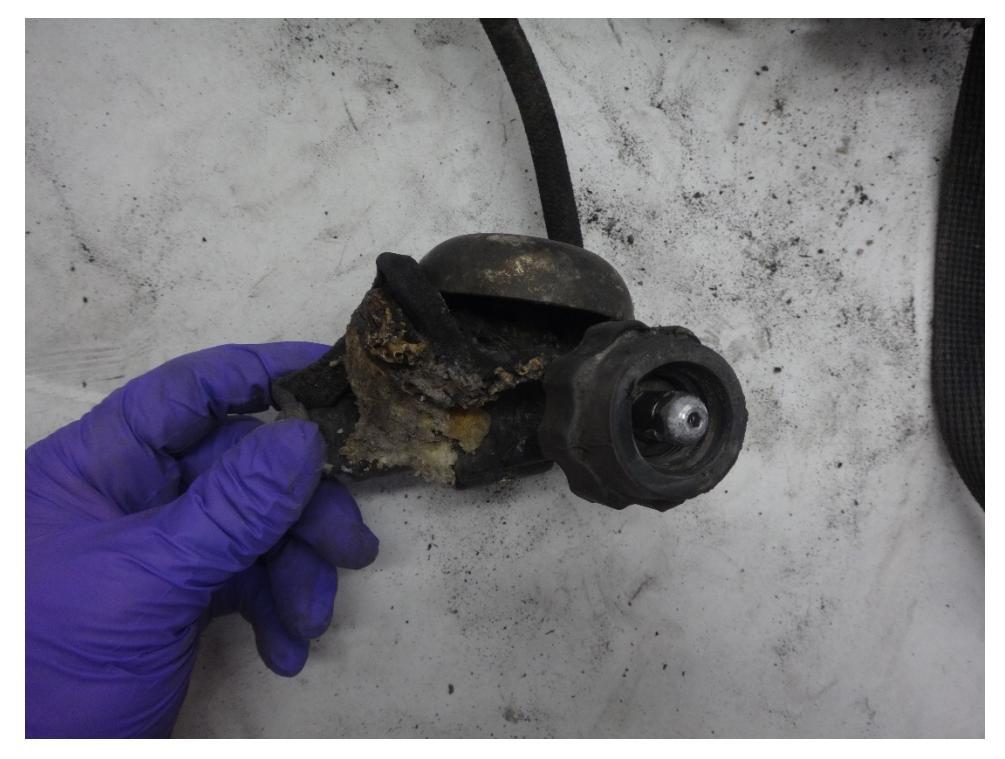
Figure 72: Cylinder attachment threads and bell assembly

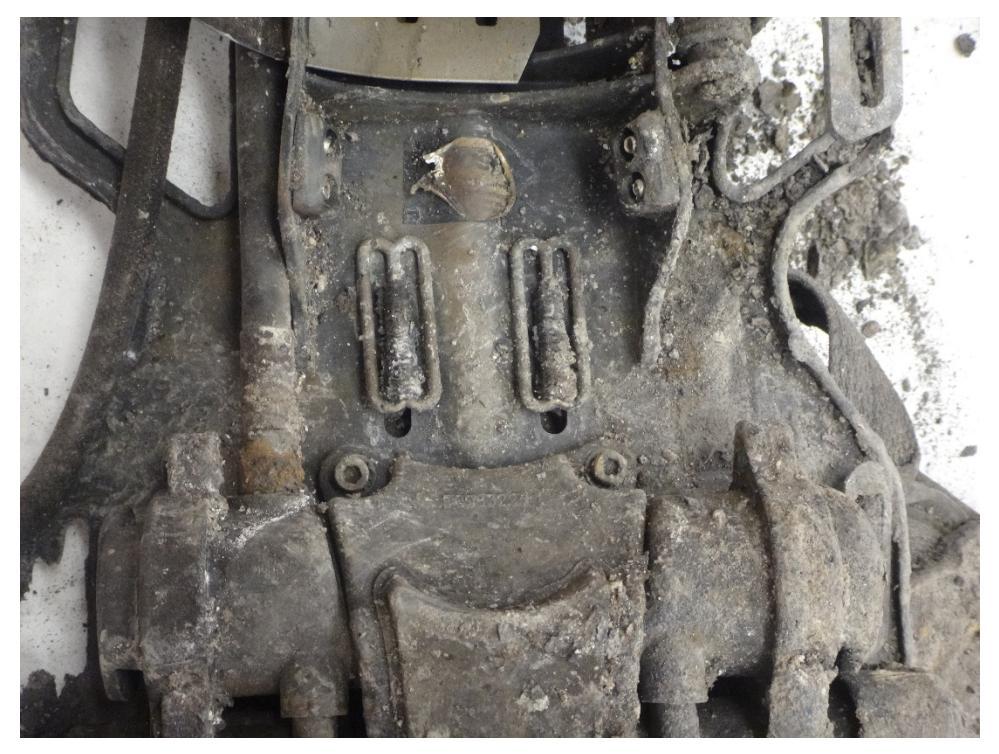
Figure 699: Top view of backframe and NIOSH sticker

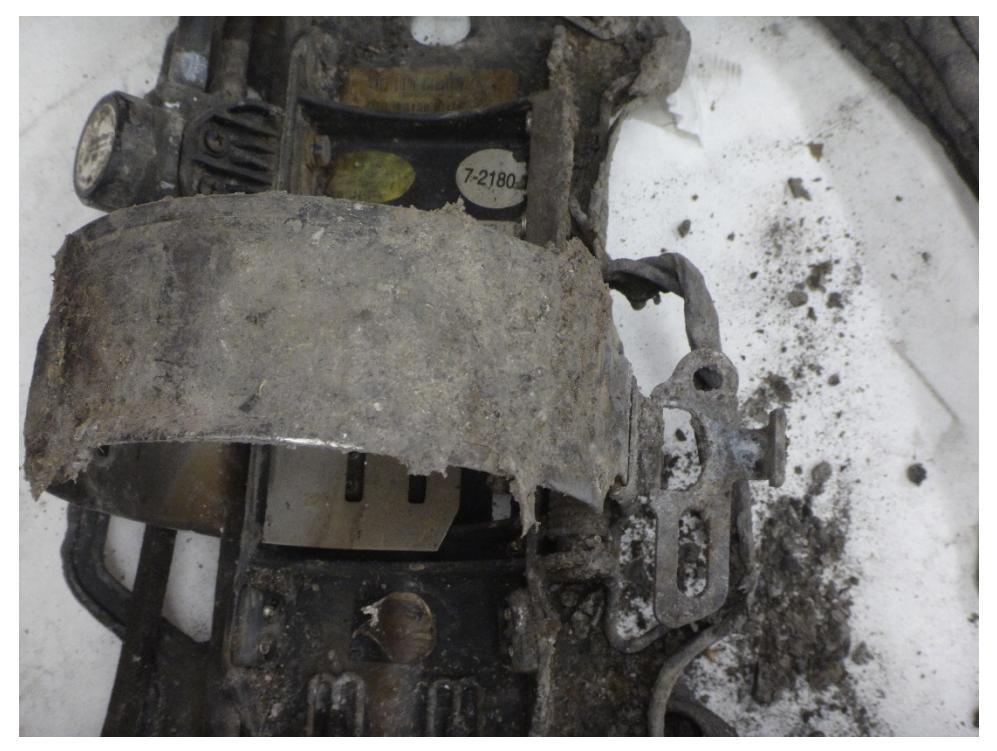
Figure 8070: Labels on backframe

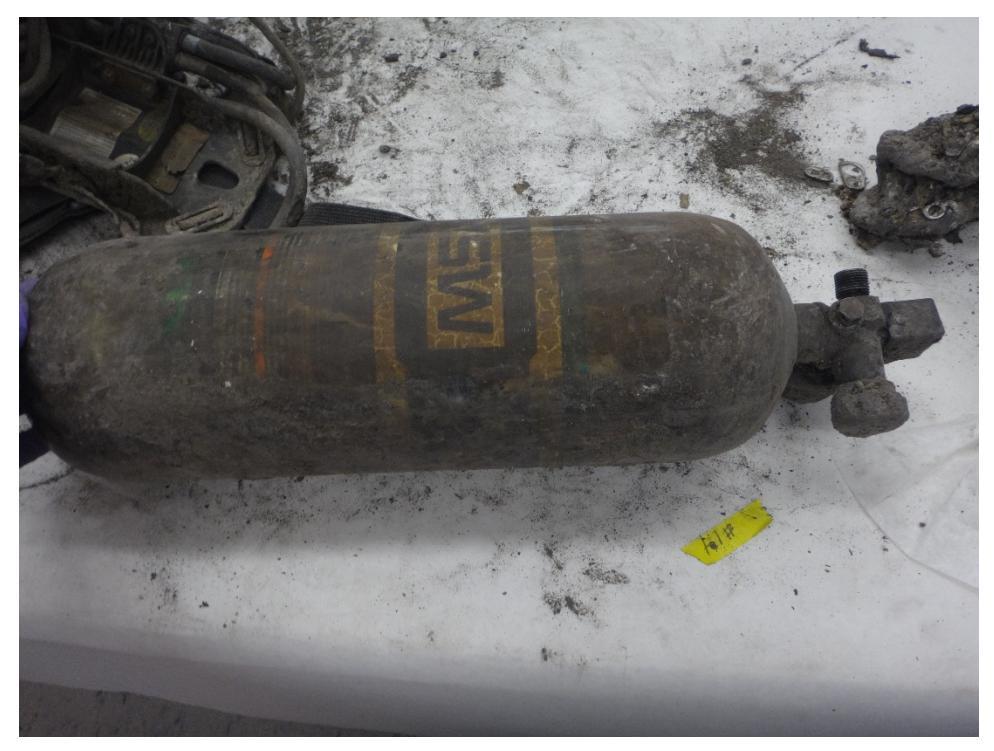
Figure 84: Top view of waist belt, straps, and buckles
